CORDRY LAKE DAM (7-1)

2023 Dam Safety Inspection Report
Brown County, IN | February 2024
Inspection Date: October 24, 2023

Burke Project No. 19.R230291.00000

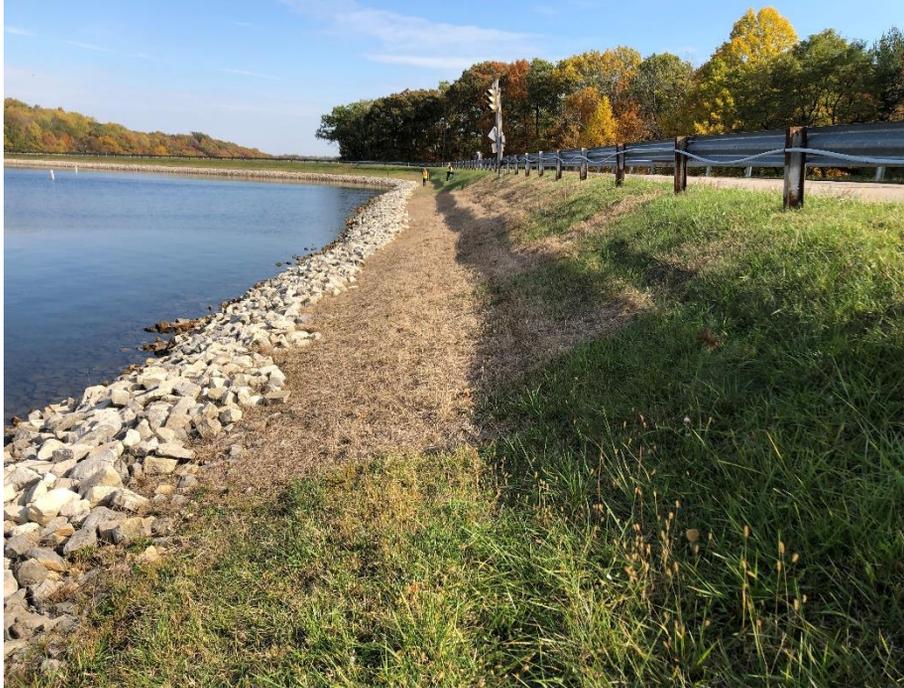
Top: Upstream slope from right side; note some dead grass above riprap. Note utility pole on tie-back section top of slope.

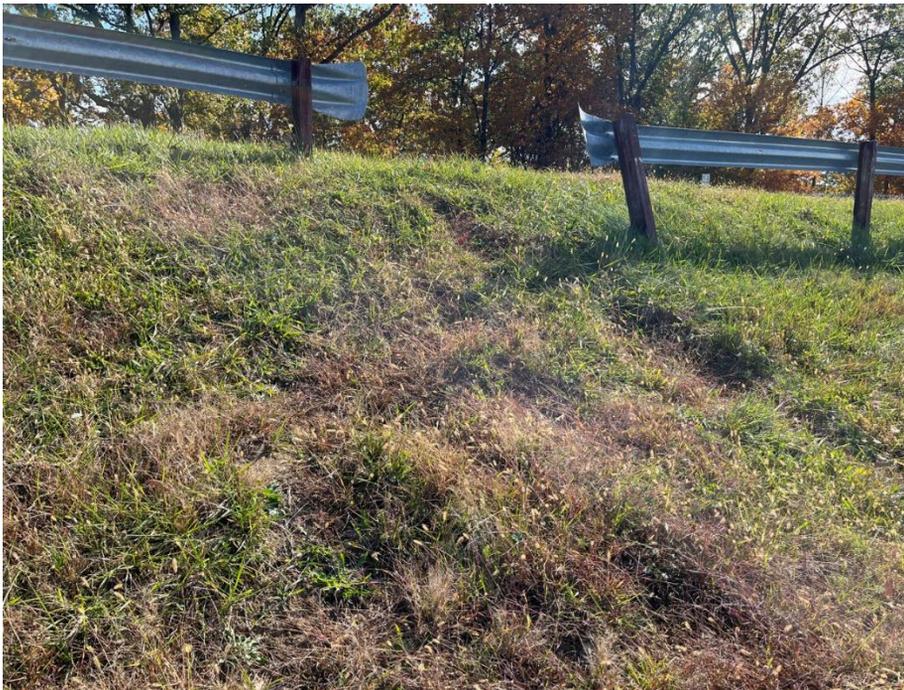
Bottom: Upstream slope; note ruts at equipment entrance

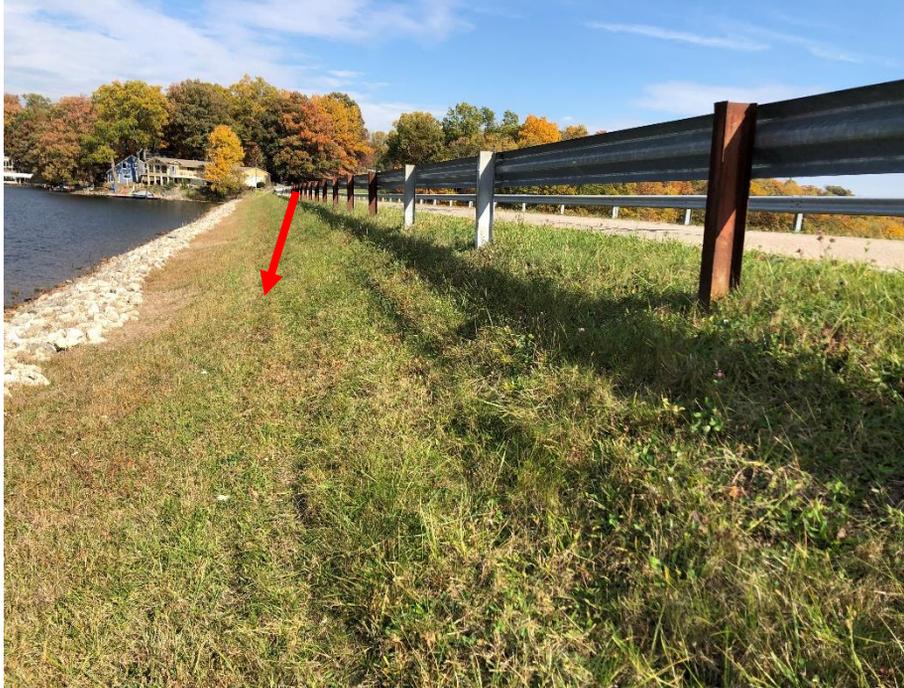
Top: Upstream slope from right side; note minor rutting at top of slope near crest

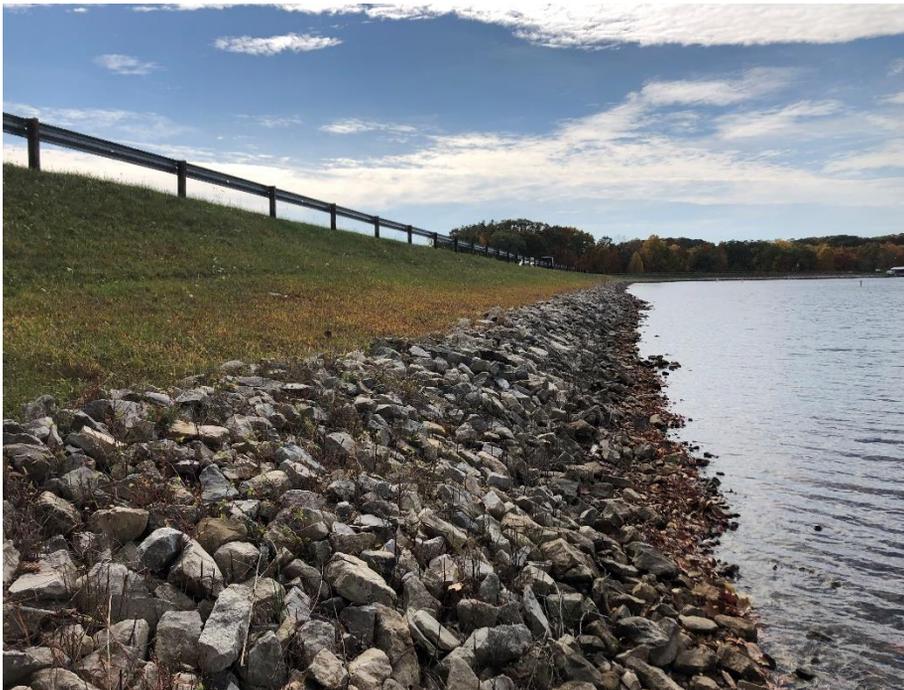
Bottom: Upstream slope from left side; note some leafy debris along shoreline

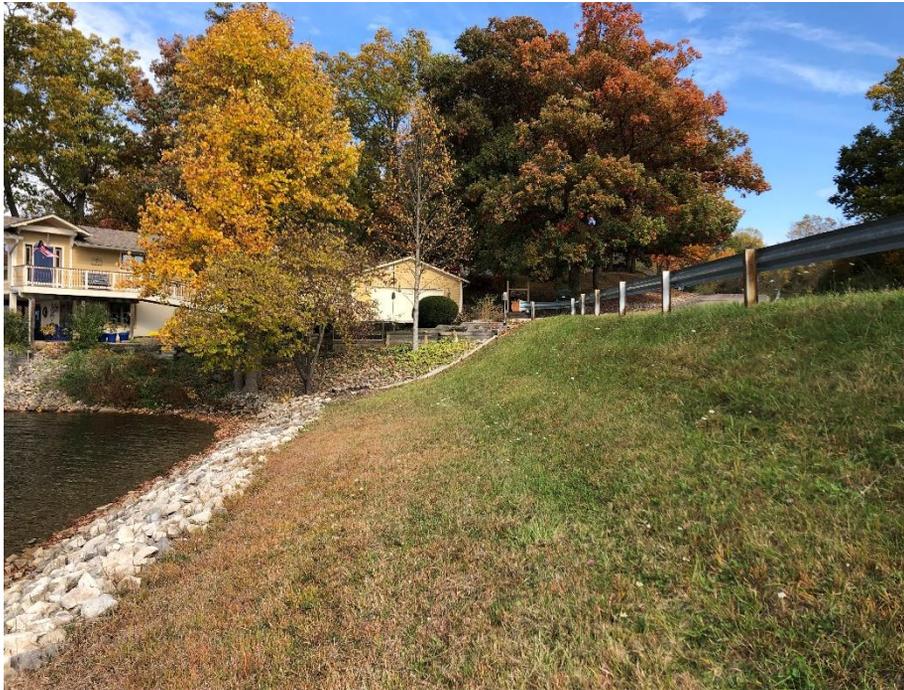
Top: Upstream slope from left side; note trees on left abutment

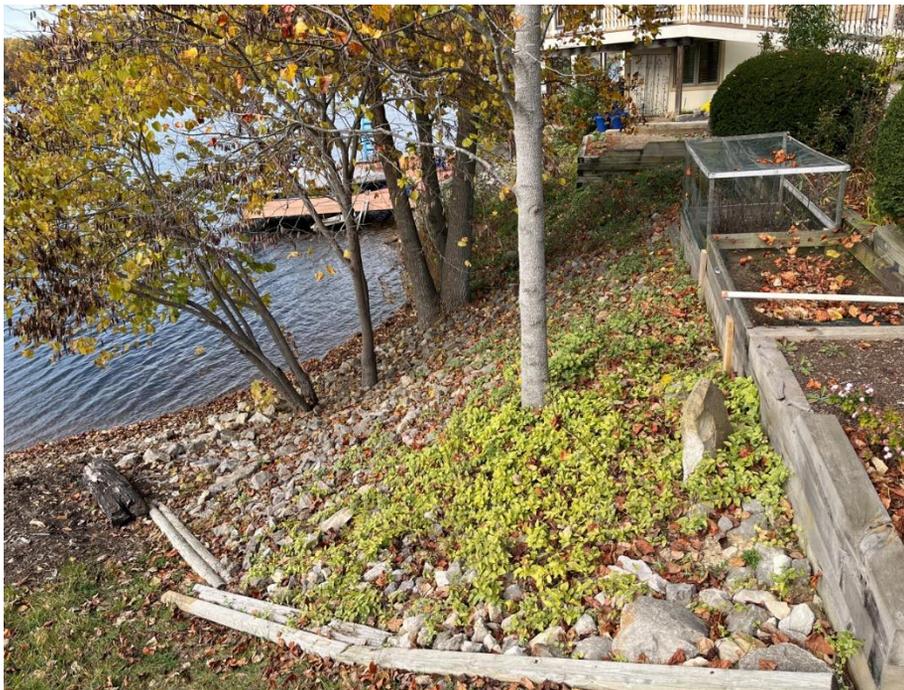
Bottom: Upstream slope at left abutment; note garden beds and landscaping on abutment

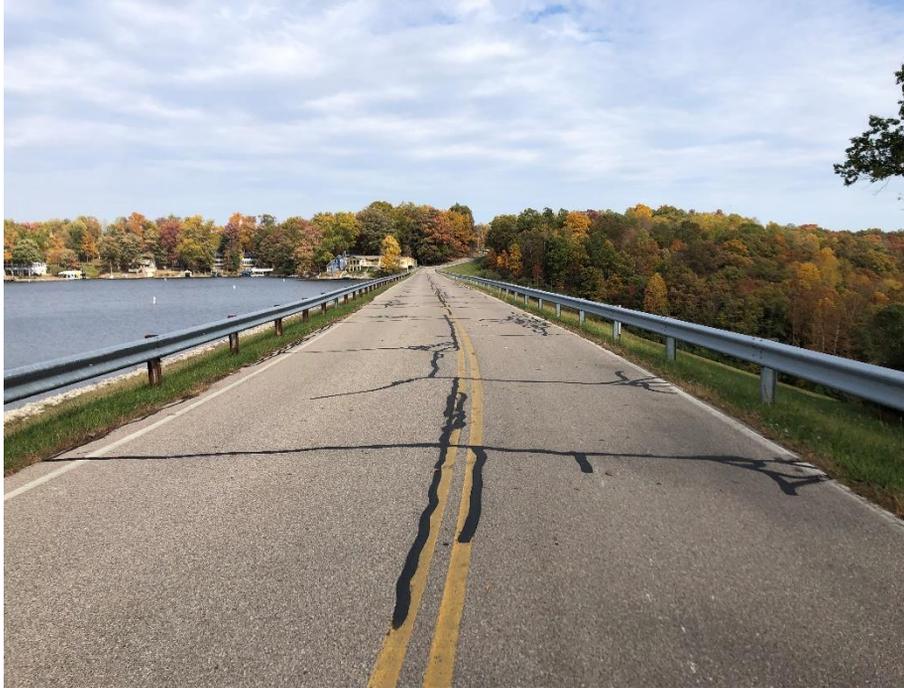
Cordry Drive is an asphalt road along the crest with guardrail on both the upstream and downstream sides. At the embankment curve, the roadway transitions to Center Lake Road along the tie-back section. The asphalt pavement surface exhibited longitudinal cracks and transverse cracks spaced approximately every 20 feet. The observed cracks appeared to have been sealed, are consistent with the age of the asphalt, and do not appear to be indicative of embankment instability. There is a utility pole on the downstream side at the right-side bend. The road appeared to have been constructed with a low point near the center of the dam. The crest width was measured by tape to be approximately 20 feet. The crest was considered “**Acceptable**” according to IDNR rating criteria.

Top: Embankment crest from right side bend; note cracking patchwork (typ.)

| Component | Rating | Recommendations | Schedule | Importance |
|---|---|--|--|---|
| Crest | Acceptable | <ul style="list-style-type: none"> Monitor cracks in asphalt pavement and seal as needed | <ul style="list-style-type: none"> Ongoing | <ul style="list-style-type: none"> Low |

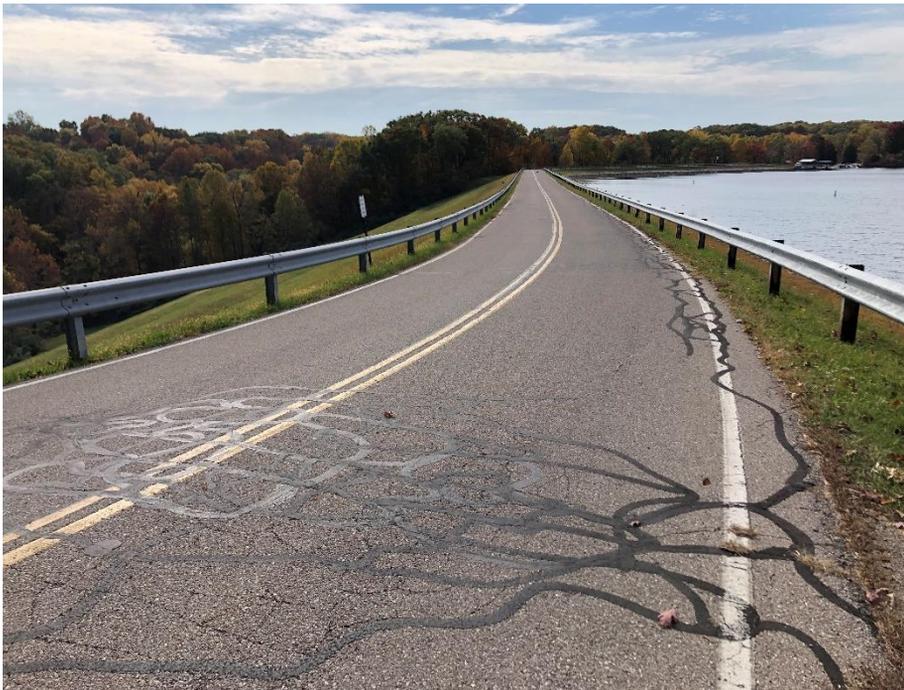
Bottom: Embankment crest from left abutment; note cracking particularly along edges (some cracks previously sealed)

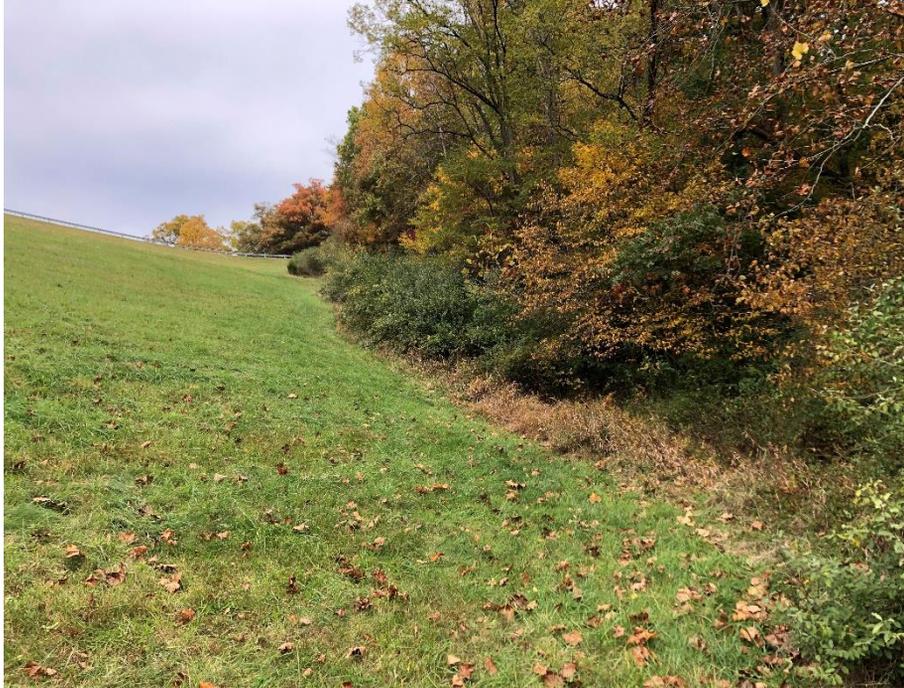
Top: Downstream slope at left abutment; note tall grass, brush, and trees within 25 feet

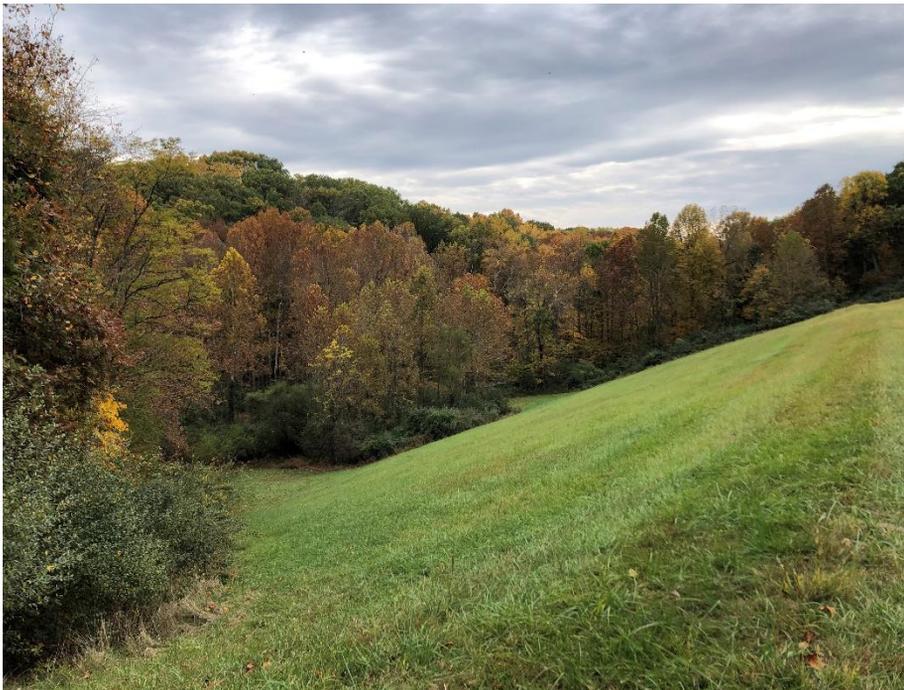
Bottom: Downstream slope on left side; note adequate grass cover and generally uniform slope. Note brush and trees within 25 feet of toe.

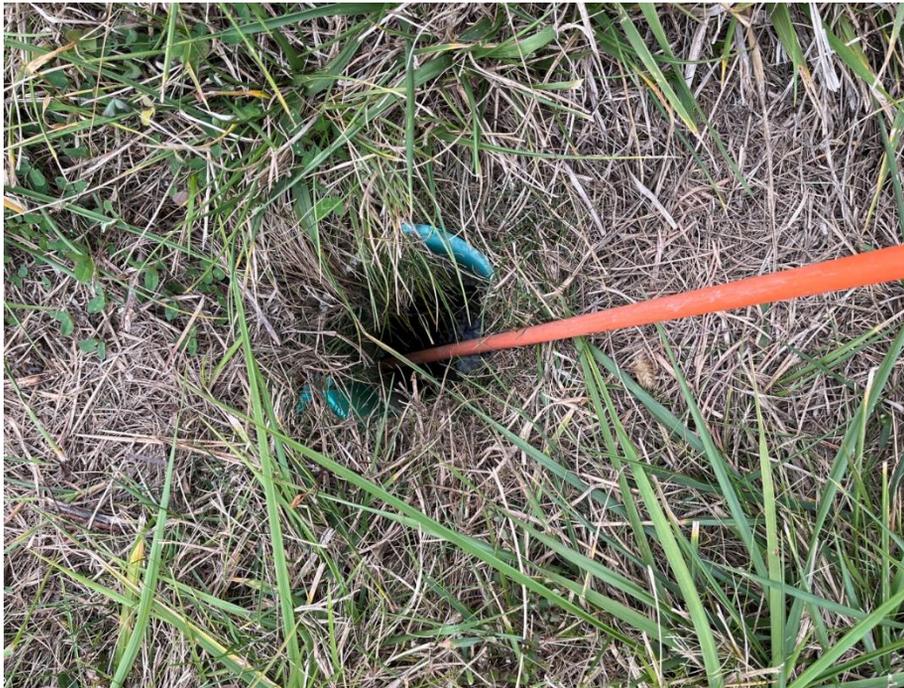
| Observation Number | Category | Component | Location | Observation |
|---|---|---|---|---|
| 48 | Drainage | Downstream Slope | Middle | Lower left drain cleanout broken and missing cap with 1" of standing water in drain |

Bottom: Downstream slope lower left bench drain (typ.) cleanout broken; some standing water in drain

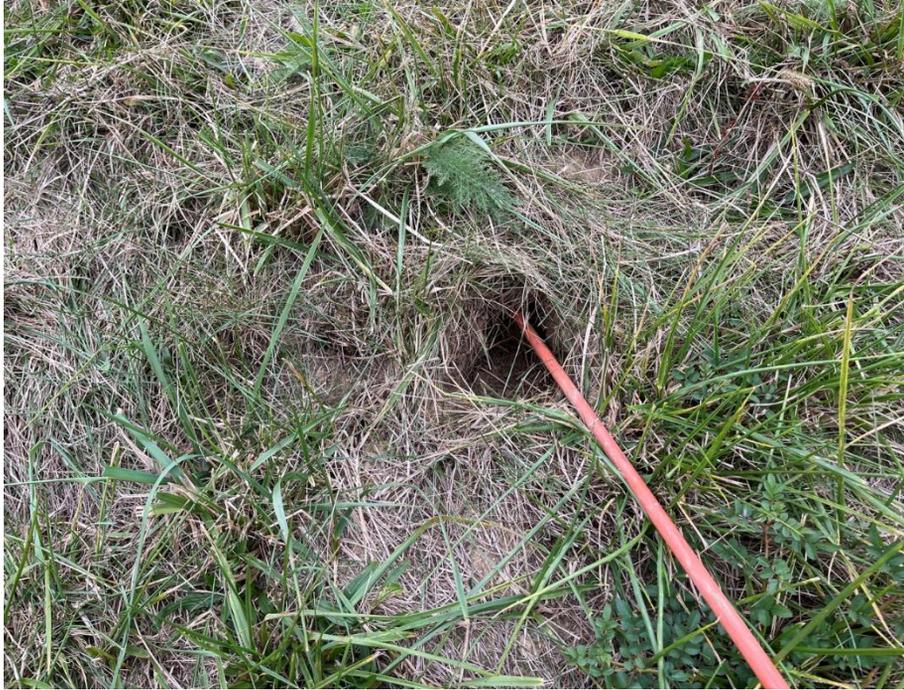
Top: Downstream slope; note small animal burrow (typ.) in upper portion of slope

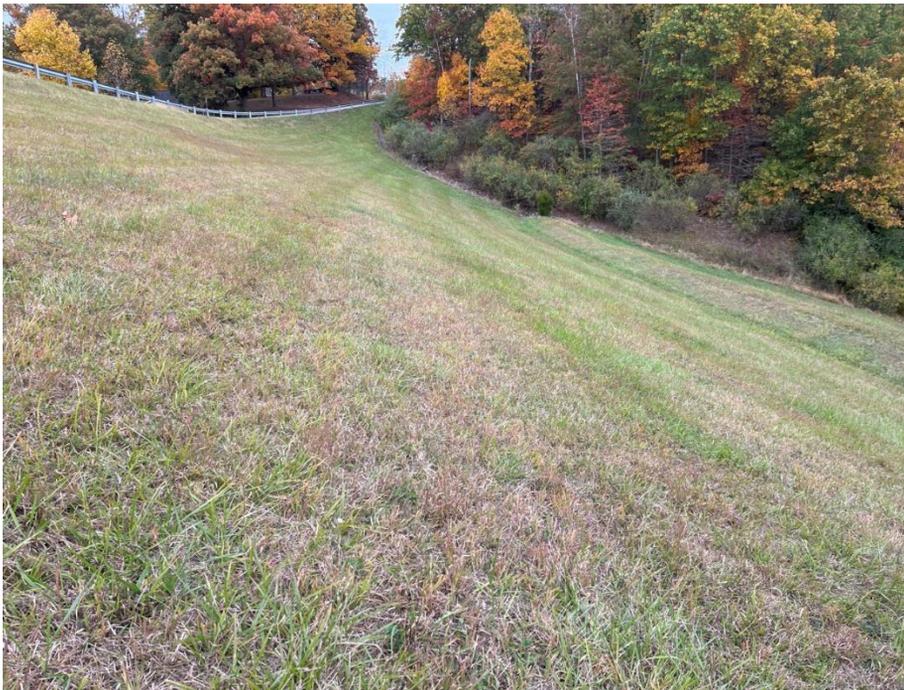
Bottom: Downstream slope on upper tier looking left; note although visually difficult to see, the entire slope was observed to be slightly hummocky

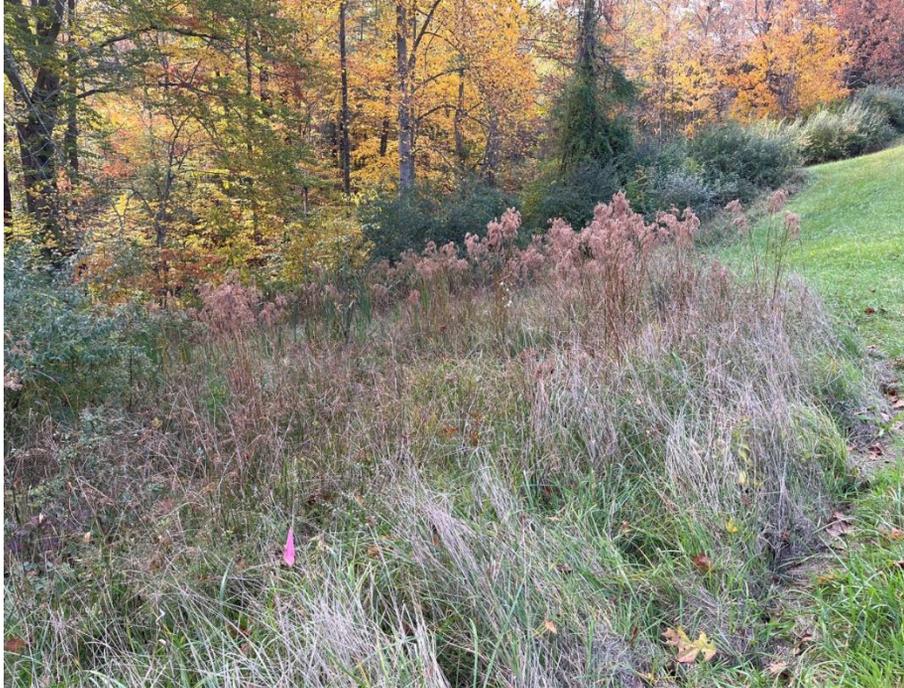
Top: Downstream slope at “tie-back” section; note 40ft by 15ft wet area observed near toe with tall grass

| Component | Rating | Recommendations | Schedule | Importance |
|---|---|--|--|---|
| Seepage | Acceptable | <ul style="list-style-type: none"> Monitor wet areas observed left of concrete chute spillway; install flags or similar around perimeter of wet areas in support of monitoring effort and notify engineer of observed changes | <ul style="list-style-type: none"> Ongoing | <ul style="list-style-type: none"> Medium |

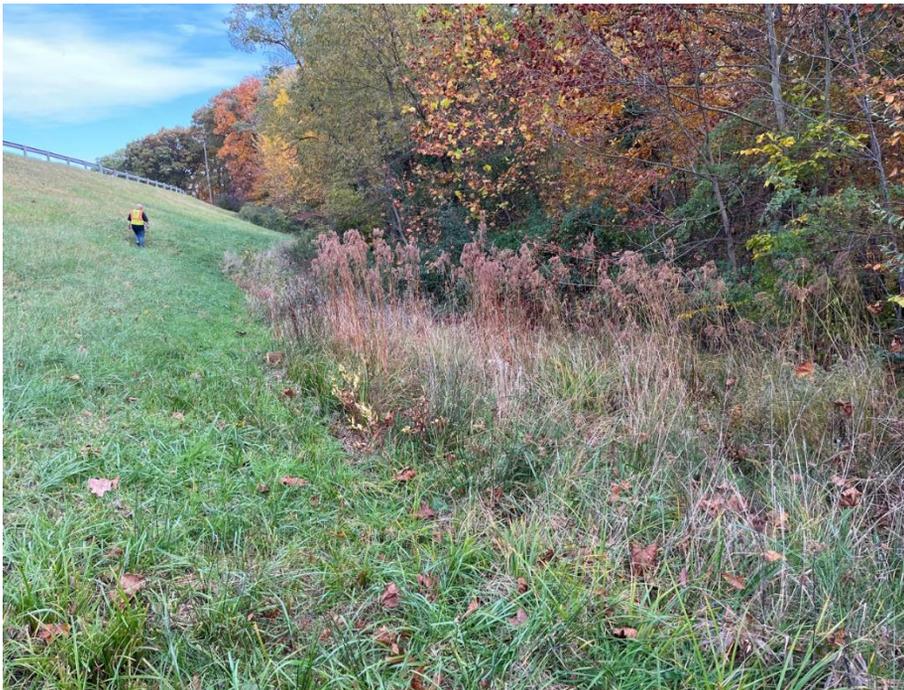
A large wet area was observed at the downstream toe of the tie-back section, approximately 150 feet left of the spillway. This area has been noted in previous inspection reports. The area was measured to be approximately 42 feet long and 20 feet wide. In addition, there is a second smaller wet area located about 300 feet left of the spillway that is approximately 40 feet by 15 feet. Previous discussions with CSCD assumed a damaged water line which runs through the embankment may have contributed to the wet areas. However, the water line has since been fixed and likely not a factor in these areas being wet. Seepage was considered “**Acceptable**” according to IDNR rating criteria.

Bottom: Downstream slope at “tie-back” section; note rutting in 42ft by 20ft wet area observed near toe with tall grass

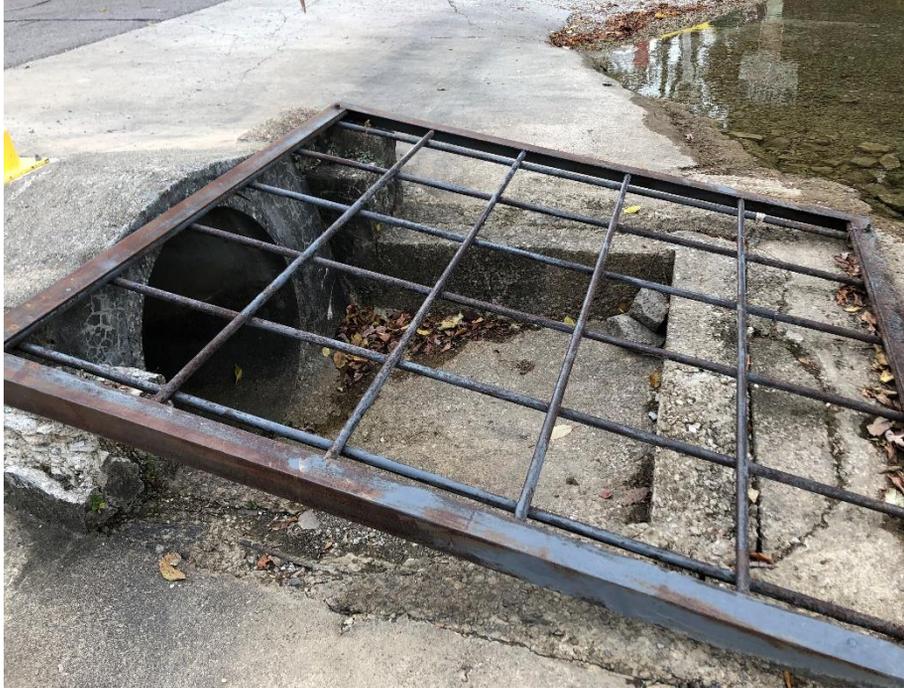
The visible portions of the concrete drop inlet structure had cracking and spalling throughout. Vegetation is growing within some of the inlet structure cracks. In addition, some rebar is exposed. The metal trash rack was observed to be weathered with loose, rusted bolts. The interior of the outlet pipe could not be inspected thoroughly but appeared to have slight variations in alignment and profile. Previously observed discharge from the pipe infiltrating a large crack in the center of the concrete chute could not be observed at the time of inspection due to the lack of flow. For the purpose of this report, the concrete chute is considered a component of the auxiliary spillway and is discussed in further detail in the following section. Note that at the time of the inspection, design plans for reconstruction of the spillway system are under development. The principal spillway was considered “**Acceptable**” according to IDNR rating criteria.

| <u>Structural factors</u> | <u>Risk Level</u> | <u>Failure Mode</u> |
|--|---|---|
| Deteriorated concrete principal spillway inlet | Low | Structural |
| Rusted trash rack hardware | Low | Structural |

Top: Principal spillway inlet; note concrete deterioration on left side and rusted trash rack hardware

| Component | Rating | Recommendations | Schedule | Importance |
|---|---|--|--|---|
| Principal Spillway | Acceptable | <ul style="list-style-type: none"> Monitor deteriorated concrete inlet monthly and after significant rainfall events while new structure is being designed and notify engineer of observed changes Monitor trash rack condition monthly and after significant rainfall events while new structure is being designed and notify engineer of observed changes | <ul style="list-style-type: none"> Ongoing Ongoing | <ul style="list-style-type: none"> High Medium |

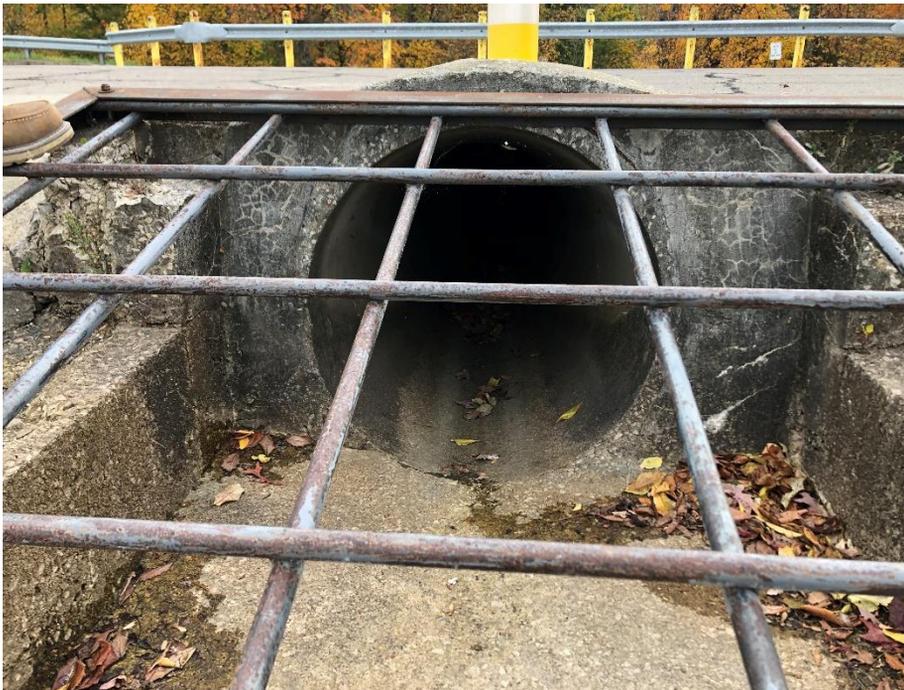
| Observation Number | Category | Component | Location | Observation |
|---|---|---|---|---|
| 59 | Structural | Principal Spillway | Inlet | Trash rack rusty with 14" by 16" openings. Concrete deteriorating with cracks, pop outs, spalls, and exposed rebar. |

Bottom: Principal spillway inlet; note concrete deterioration cracking and spalling

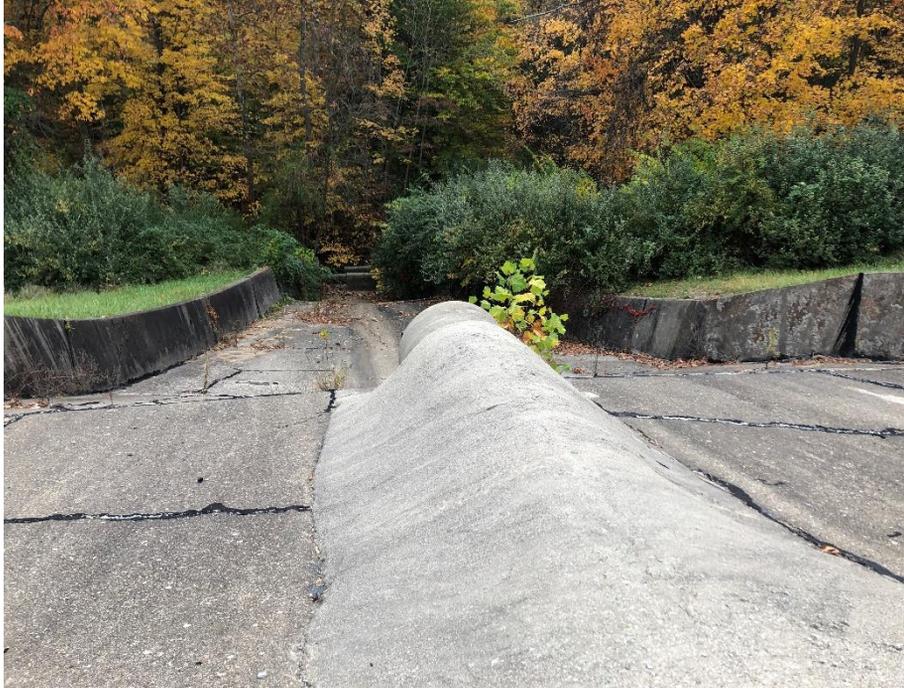
Top: Principal spillway outlet; note exterior of spillway pipe appeared in good condition

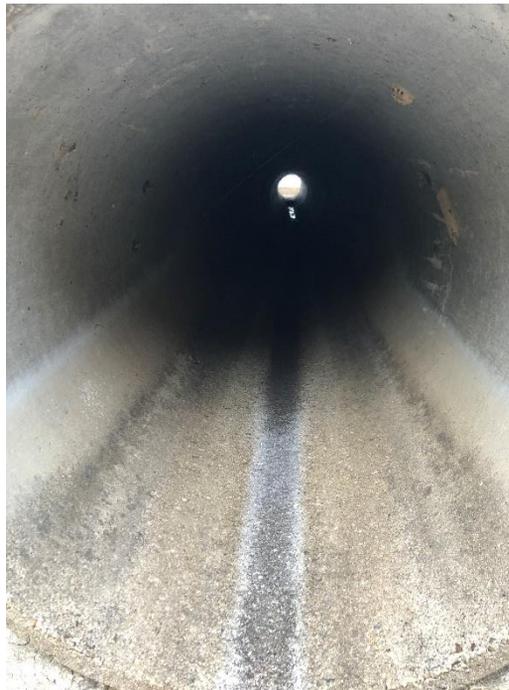
Bottom: Principal spillway outlet; note interior of pipe could not be thoroughly inspected

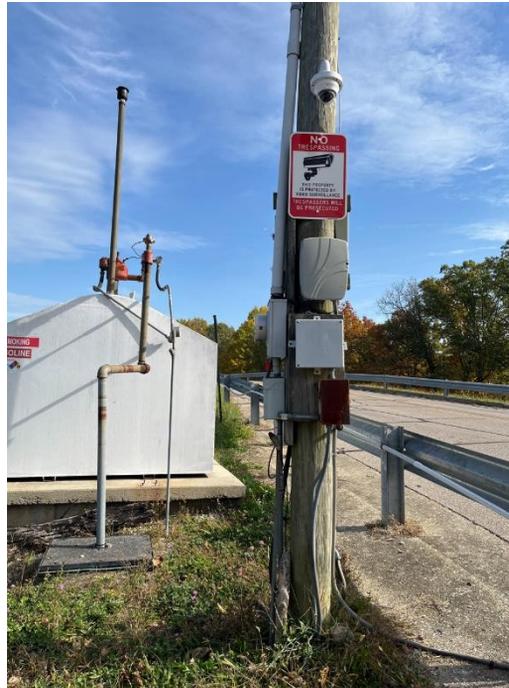
Top: Auxiliary spillway inlet; note dock, utility pole and fuel tank on the left upstream side

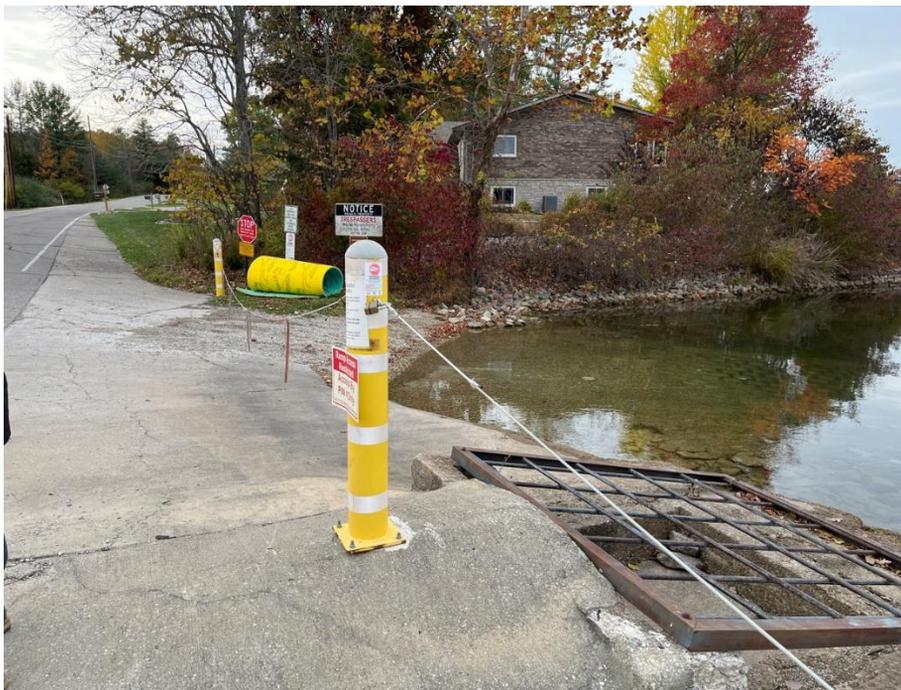
The asphalt road serves as the crest of the auxiliary spillway. Trees and brush encroach the right upstream side of the spillway. Also, on the right upstream side of the spillway inlet is a boat ramp comprised of articulated concrete mating that extends into the lake. Encroaching the left side of the upstream inlet section is a boat dock, fuel tank mounted on a concrete pad, and utility pole. Metal guardrail and concrete bollards observed on the downstream side of the crest would likely obstruct flow but to an unknown extent. The spillway crest roadway surface exhibits several patched areas with some concrete pop-outs along the curb on the downstream side. Vegetation is growing within some of the cracks between concrete curb and roadway surface. Visible portions of the downstream concrete chute had varying degrees of cracking and spalling throughout the chute floor and walls as well as on the baffle blocks. Some cracks did appear to be sealed but some had vegetation growing through. Spalling was observed to be more significant near the downstream end of the chute. There appeared to be an area near the upper left side of the chute showing signs of delamination. The natural channel downstream of the concrete chute is eroding and may impact the structural integrity of the concrete chute if it propagates. Less than one gallon per minute of seepage appeared to be flowing beneath the concrete chute potentially undermining the structure since the lake level was below normal pool. It should be noted that an existing water line runs directly below the concrete chute. The 6-inch clay underdrain for the concrete chute appears to no longer be operational. Brush was observed to be encroaching over the chute walls, particularly towards the downstream end. Note that at the time of the inspection, design plans for reconstruction of the spillway system are under development. The auxiliary spillway was considered “**Deficient**” according to IDNR rating criteria.

Bottom: Auxiliary spillway inlet; note trees and brush encroaching by signs. Note articulated concrete block mat extends into lake for boat ramp access. Note bollards on upstream side of road.

| Component | Rating | Recommendations | Schedule | Importance |
|---|---|--|--|---|
| Auxiliary Spillway | Deficient | <ul style="list-style-type: none"> Remove trees and brush within 25 feet of the right inlet section and outlet walls in accordance with the Indiana Dam Safety Inspection Manual Spray/Remove vegetation growing through the cracks of the concrete chute Monitor the concrete condition of the spillway chute and erosion of the downstream channel monthly and after significant rainfall events while new structure is being designed and notify engineer of observed changes | <ul style="list-style-type: none"> Within 2 years Ongoing Ongoing | <ul style="list-style-type: none"> Medium Low High |

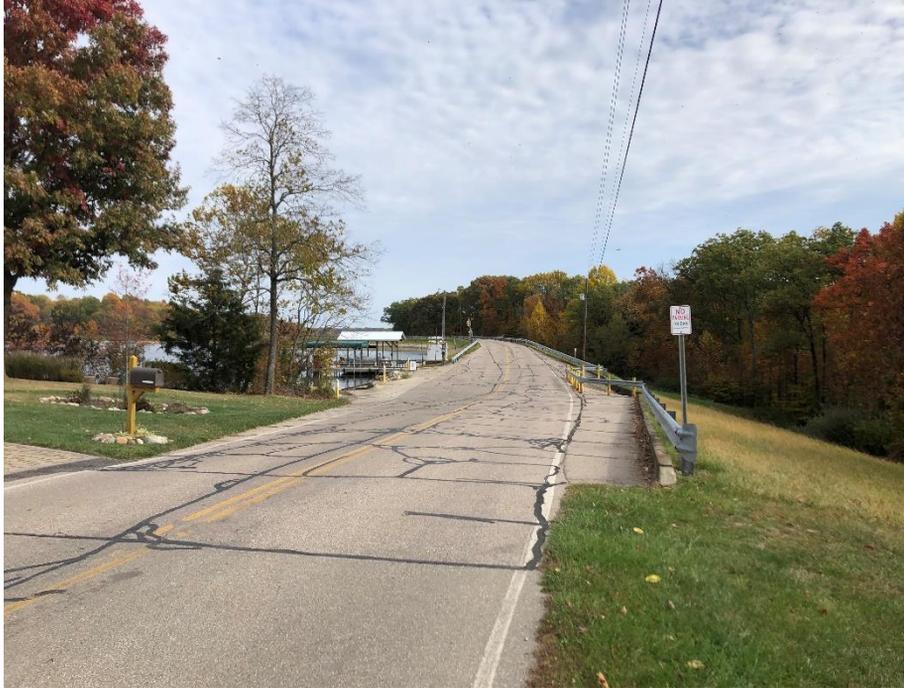
Top: Auxiliary spillway crest; note roadway surface with guardrail bollards at the downstream edge.

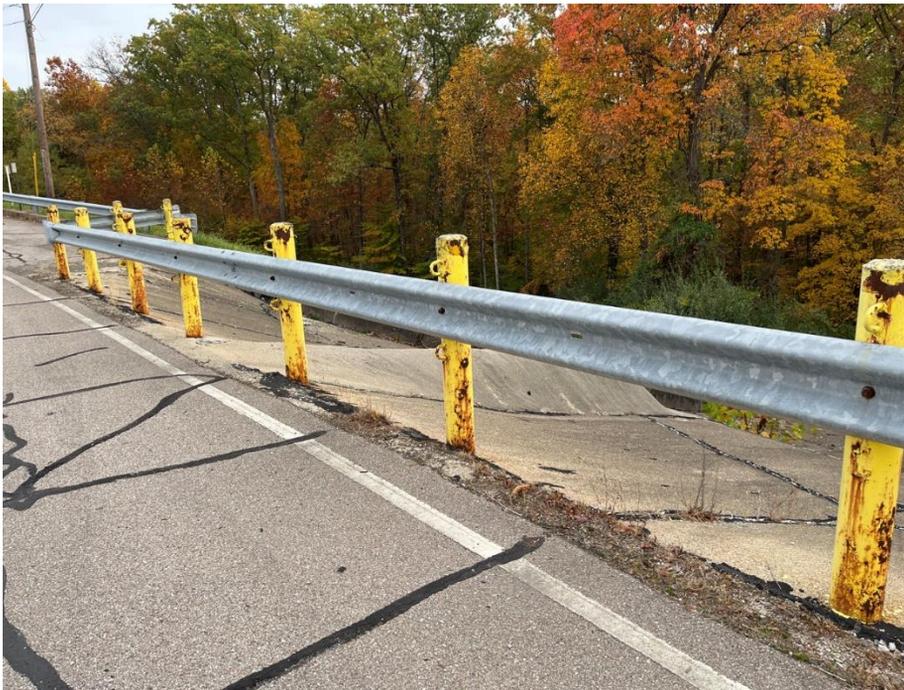
Bottom: Auxiliary spillway crest; note guardrail and bollards at the downstream edge

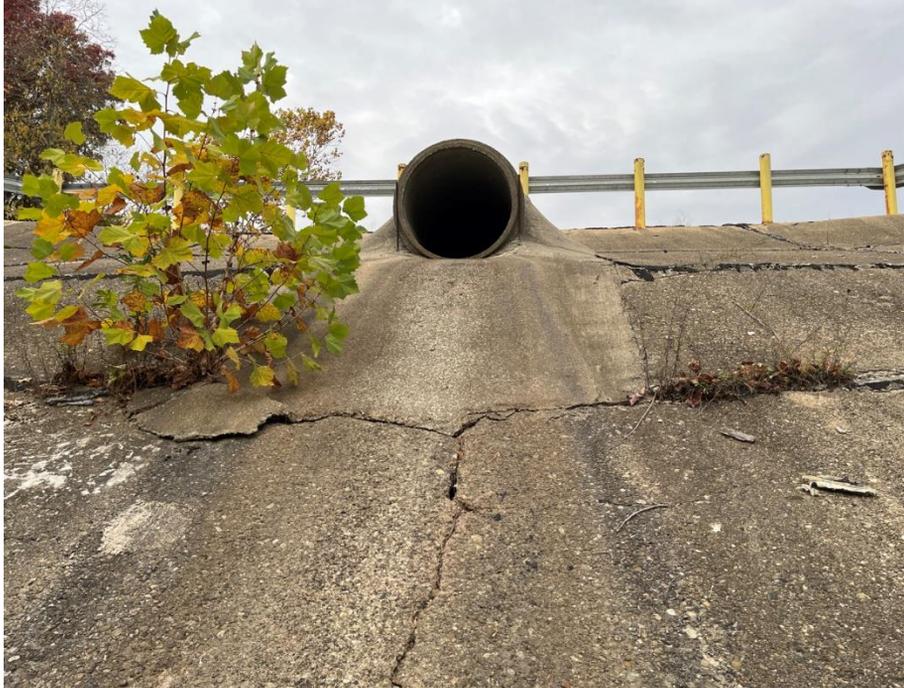
| Observation Number | Category | Component | Location | Observation |
|---|---|---|---|---|
| 69 | Structural | Auxiliary Spillway | Outlet | Concrete cracking and deterioration throughout. Some vegetation growing in cracks. |

Top: Auxiliary spillway concrete chute; note condition of concrete and vegetation growth in cracks

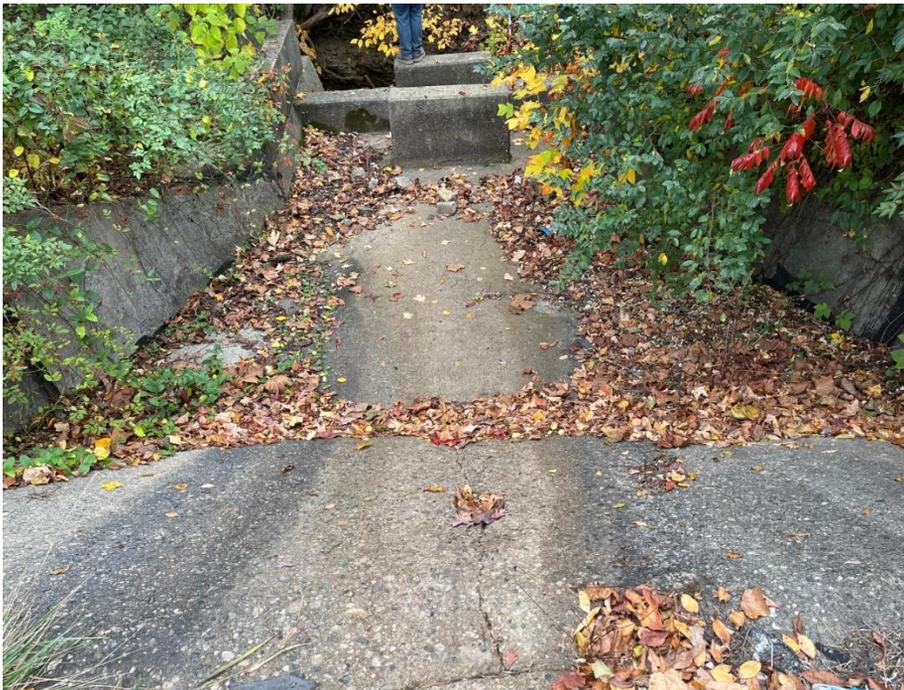
Bottom: Auxiliary spillway concrete chute; note vegetation growth intruding along wall sections

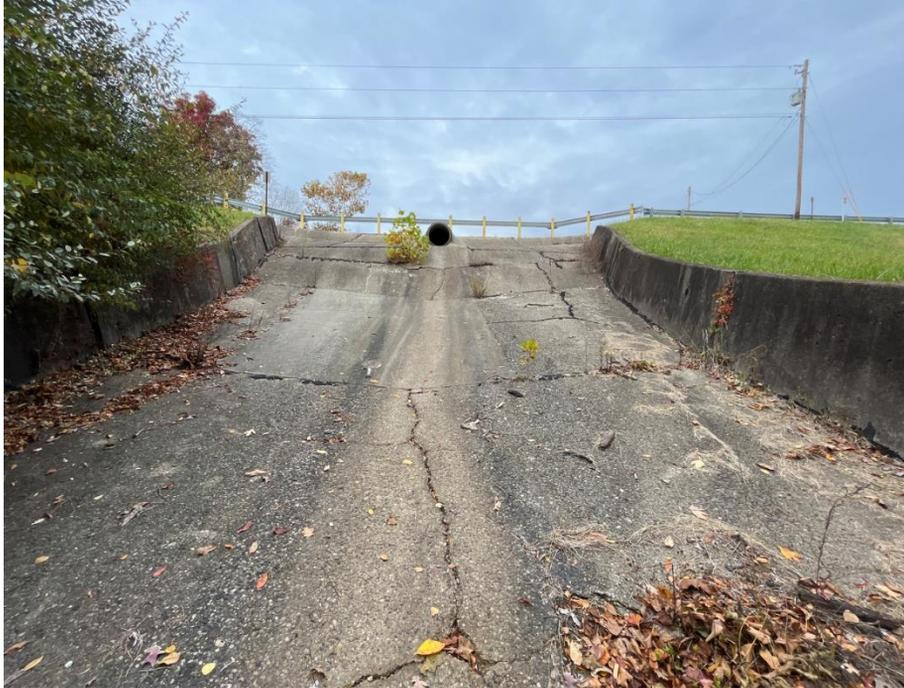
| <u>Structural factors</u> | <u>Risk Level</u> | <u>Failure Mode</u> |
|--|---|---|
| Deteriorated concrete chute spillway | Medium | Hydraulic/Structural |

Top: Auxiliary spillway concrete chute; note condition of concrete (cracking, spalling)

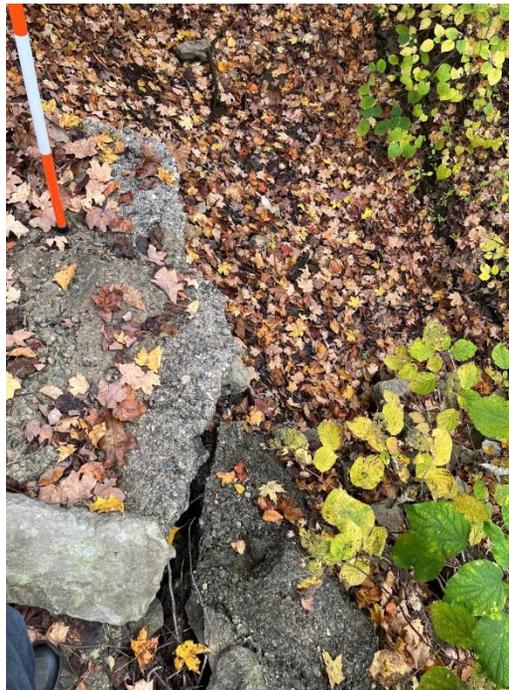
Bottom: Auxiliary spillway end of concrete chute; note cracked concrete and some seepage observed flowing under the concrete structure
