# Lake of the Woods Vacuum Sewer Evaluation

Locust Grove, VA

RAPSA 177782 | November 20, 2024

Please accept the enclosed Technical Report summarizing the Lake of the Woods vacuum sewer evaluation. This technical report includes a condition assessment of each vacuum sewer station and an analysis of recommended improvements.

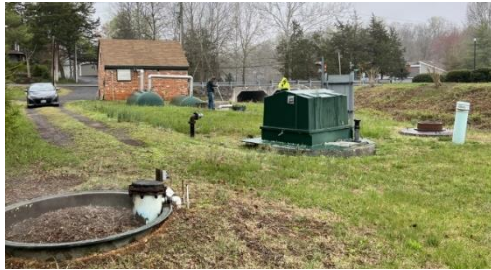
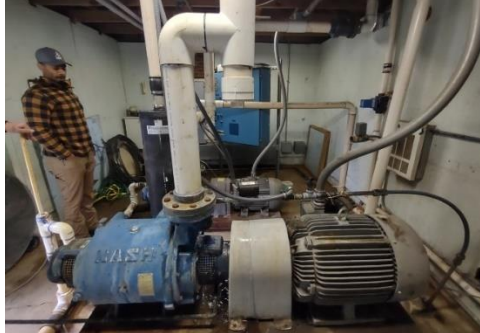
Vacuum Station ID	Condition Assessment Key Observations
<p><b>Station A</b></p>

<ul style="list-style-type: none"> <li>The station was upgraded in 2009-2010 during construction of the Locust Grove Middle School, which discharges wastewater to the sewage pumping station via a dedicated forcemain.</li> <li>The building consists of CMU and slab on grade construction with brick veneer. Interior is faced with plywood. Building is generally in acceptable condition for continued use.</li> <li>Building footprint is adequate to house proposed SC7 vacuum pumps and controls with appropriate clearances.</li> <li>Vacuum system requires both pumps to run continuously, which provides no redundancy. Both vacuum pumps replaced in approximately 2008.</li> <li>Sewage pump station was replaced in approximately 2008. Condition is acceptable for continued use.</li> <li>Concrete wetwell is coated with an epoxy liner.</li> <li>Odor control unit was recently (&lt;10 years) replaced with stand-alone biofilter in fiberglass basin.</li> </ul>

<ul style="list-style-type: none"> <li>• Electrical systems were replaced in approximately 2008 and appear to be in acceptable condition. May require replacement due to upsizing equipment.</li> <li>• A 100kW generator is provided to power the station.</li> </ul>
<p><b>Station B</b></p>

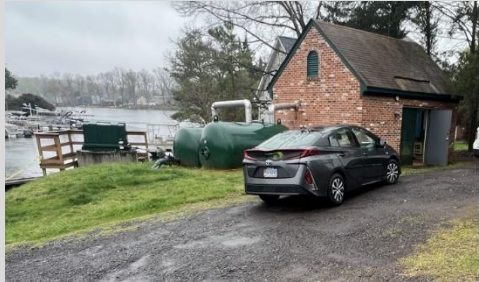
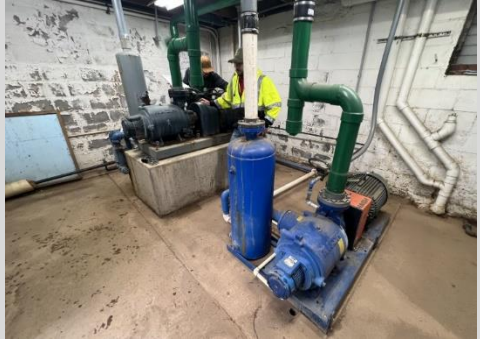
<ul style="list-style-type: none"> <li>• The building consists of CMU block slab on grade with brick veneer. Building is in acceptable condition for rehabilitation and continued use. Building footprint is smaller than desired to house SC7 vacuum pumps and controls, but could be used with reduced clearances or by locating some electrical equipment in outdoor enclosures.</li> <li>• Odor control unit is attached to the building. The RSA has noted deterioration of exterior walls over time in this configuration.</li> <li>• Available space on the site is very limited.</li> <li>• Vacuum system requires both pumps to run continuously. There is inadequate redundancy. One vacuum pump was replaced in 2018. The other vacuum pump is more than 20-years old, and is beyond useful life.</li> <li>• One vacuum pump sits on floor (lacks concrete pedestal).</li> <li>• Sewage pump station is beyond useful life. One pump was replaced with a different capacity/model pump salvaged from a different pump station. Vibration/slamming observed on startup.</li> <li>• Wet well is approximately 15' from the edge of the lake and is built in to sloped bank. Access from wooden platform is limited.</li> <li>• Concrete wetwell exhibits concrete degradation with exposed aggregate.</li> <li>• Electrical systems are beyond useful life and require replacement.</li> <li>• A plug for portable generator is provided.</li> </ul>

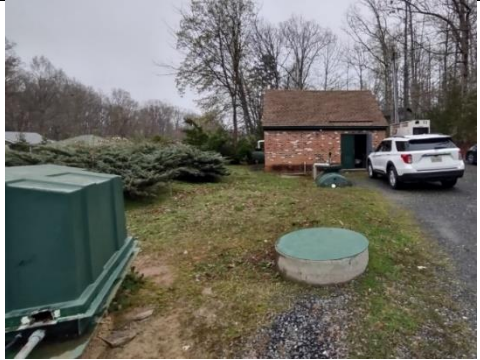
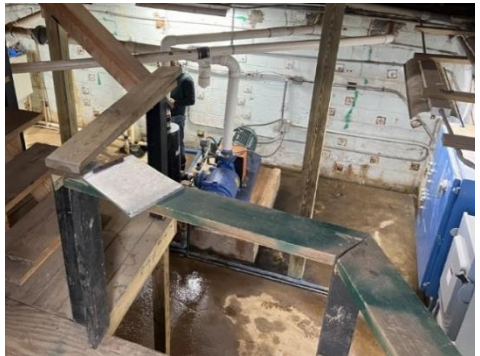
<p><b>Station C</b></p>	<ul style="list-style-type: none"> <li>• The building consists of CMU block below grade. CMU exhibits step cracking. Building was damaged during an earthquake (&gt;10 years ago). Buried reinforcement was installed outside to stabilize CMU.</li> <li>• Building consists of wood framing above grade with brick veneer. Wood framing particle board sheathing is in poor condition (water/humidity damage) and requires replacement.</li> <li>• Access to remove/replace pumps is difficult. Interior stairs do not meet current building codes.</li> </ul>

<ul style="list-style-type: none"> <li>• Building relies on duplex sump pumps to remove groundwater and vacuum pump cooling/seal water. Sump pump failure would flood the station. Floor flood alarms not present.</li> <li>• Vacuum system requires both pumps to run continuously, no redundancy. One vacuum pump was replaced in 2018. The other vacuum pump was replaced in 2019. Both pumps run loud, moderate/poor condition considering age &lt;10 years.</li> <li>• Sewage pump station is beyond useful life. One pump was replaced with a different capacity/model pump salvaged from a different pump station.</li> <li>• Significant infiltration observed into wetwell (10 gpm)</li> <li>• Electrical systems (except generator) are beyond useful life and require replacement.</li> <li>• A 125 kW generator was installed in 2018.</li> </ul>
<p data-bbox="370 974 487 1003"><b>Station D</b></p>

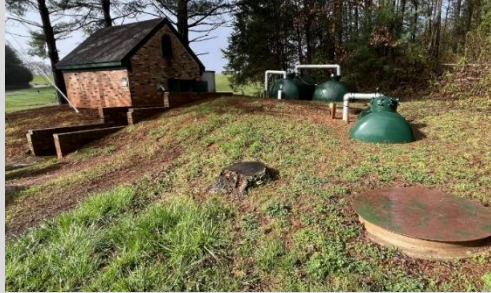
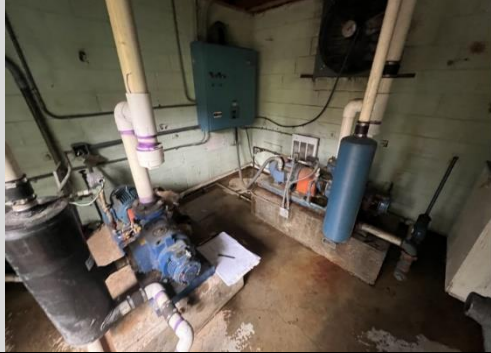
<ul style="list-style-type: none"> <li>• The building consists of a partially buried CMU and slab construction with brick veneer. Building is generally in acceptable condition for continued use.</li> <li>• Building footprint is adequately sized for existing equipment but does not provide space for increasing the vacuum pump size and housing electrical control panels.</li> <li>• The existing building is in the 100-year floodplain (Zone AE).</li> <li>• Vacuum system operates with both pumps on, no redundancy. One pump was installed in 2008 and the other was installed in 2018. Both pumps exhibit corrosion of the of the pump housing.</li> <li>• Odor control unit was recently (&lt;10 years) replaced with stand-alone biofilter in fiberglass basin. The odor control unit lacks a drain.</li> <li>• Electrical systems are beyond end of useful life.</li> <li>• A portable generator plug is provided to power the station during power outages.</li> </ul>

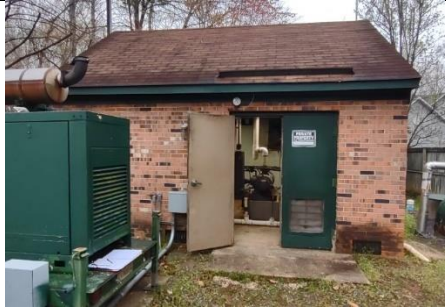
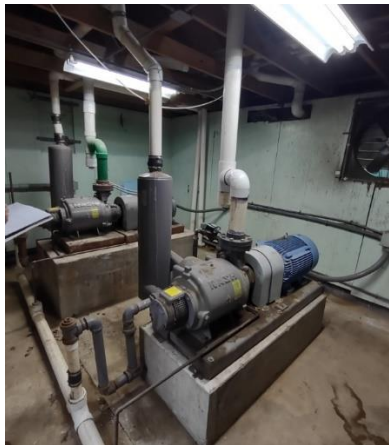
<p data-bbox="370 1724 487 1753"><b>Station E</b></p>	<ul style="list-style-type: none"> <li>• The building consists of CMU &amp; slab on grade with brick veneer. Building exterior exhibits step cracking. The interior is faced with plywood in poor condition.</li> </ul>

<ul style="list-style-type: none"> <li>• The building footprint is too small to house proposed vacuum pumps and electrical/control panels.</li> <li>• Odor control unit is attached to the building. The RSA has noted deterioration of exterior walls over time in this configuration.</li> <li>• Vacuum system requires both pumps to run continuously, no redundancy. Both vacuum pumps are more than 20-years old, and are beyond useful life.</li> <li>• Sewage pump station is beyond useful life.</li> <li>• Concrete wetwell exhibits concrete degradation with exposed aggregate.</li> <li>• Electrical systems are beyond useful life and require replacement.</li> <li>• A plug for portable generator is provided and a portable generator is connected to the transfer switch.</li> </ul>
<p><b>Station F</b></p>

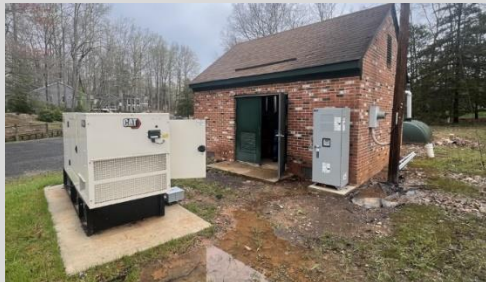
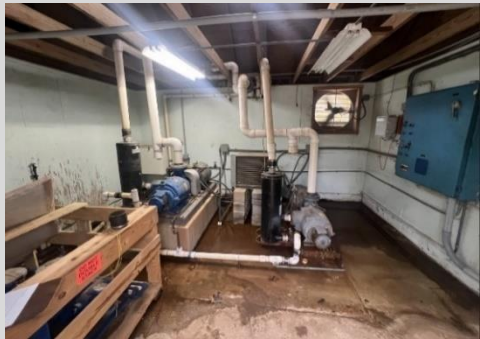
<ul style="list-style-type: none"> <li>• The building consists of CMU and slab on grade construction with brick veneer. Building is in acceptable condition.</li> <li>• Building footprint is adequate to house proposed vacuum pumps and controls.</li> <li>• Vacuum system requires both pumps to run continuously, no redundancy. One vacuum pumps was installed in 2008, and one is in excess of 20 years old. Both pumps are nearing/beyond end of useful life.</li> <li>• Sewage pump station is approximately 30-years old &amp; is beyond useful life.</li> <li>• Concrete wetwell exhibits concrete degradation with exposed aggregate.</li> <li>• Odor control unit was recently (&lt;10 years) replaced with stand-alone biofilter in fiberglass basin.</li> <li>• Electrical systems (except generator) are beyond useful life and require replacement.</li> <li>• A 100kW generator is provided.</li> </ul>

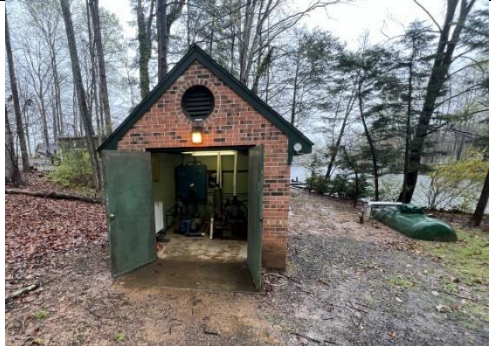
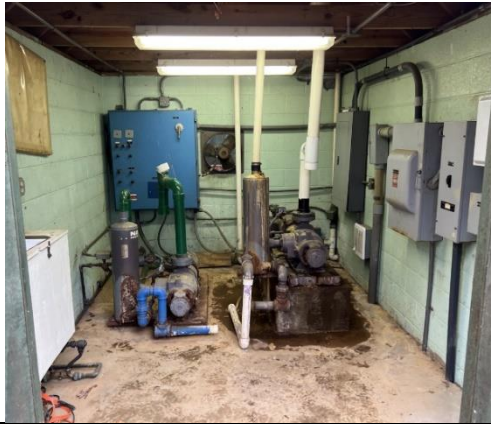
<p><b>Station G</b></p>	<ul style="list-style-type: none"> <li>• The building consists of CMU and slab on grade construction with brick veneer. Building is generally in acceptable condition for continued use.</li> </ul>

<ul style="list-style-type: none"> <li>• Building footprint is not adequately sized to provide required clearances for existing or proposed equipment and electrical panels. The current configuration does not provide enough space to safely perform maintenance tasks on the equipment.</li> <li>• Vacuum system operates with one pump on and one pump in standby. Both pumps were installed in 2001 and are beyond end of useful life.</li> <li>• Sewage pump station equipment was replaced in 2014. The motor, upper volute, impeller, and mechanical seal of the old pumps were maintained. An epoxy coating was applied to the wet well.</li> <li>• Odor control unit is attached to the building. The RSA has noted deterioration of exterior walls over time in this configuration.</li> <li>• Electrical systems are beyond end of useful life and code required clearances are not provided.</li> <li>• A portable generator plug is provided to power the station during power outages.</li> </ul>

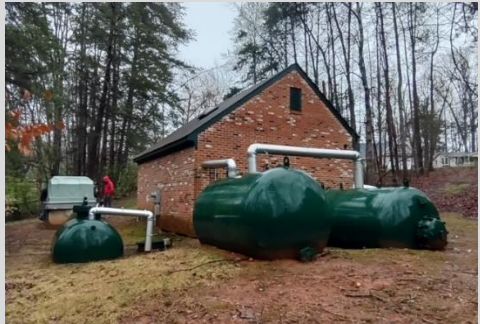
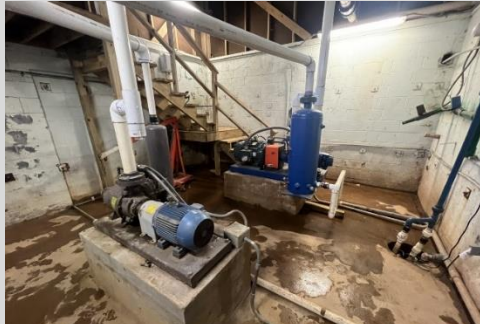
<p data-bbox="370 1031 487 1058"><b>Station H</b></p>

<ul style="list-style-type: none"> <li>• The building consists of CMU block below grade. CMU exhibits step cracking. Building was reportedly damaged during an earthquake (&gt;10 years ago). Buried reinforcement was installed outside and lag bolted to the foundation wall to stabilize the CMU.</li> <li>• Building consists of wood framing above grade with brick veneer. Wood framing particle board sheathing is in poor condition (water/humidity damage) and requires replacement.</li> <li>• Building footprint is adequately sized to provide required clearances for existing and proposed equipment and electrical panels. However, access to remove/replace pumps is difficult. Interior stairs do not meet current building codes.</li> <li>• Building relies on duplex sump pumps to remove groundwater and vacuum pump cooling/seal water. Sump pump failure would flood the station. Floor flood alarms not present.</li> <li>• Vacuum system was originally equipped with duplex SC2 pumps. However, the SC2 pump does not keep up with peak flows and one was replaced with SC3 model in 2022. The remaining SC2 model was installed in 2001 and is beyond end of useful life.</li> <li>• Sewage pump station equipment was replaced recently. An epoxy coating was applied to the wet well.</li> </ul>

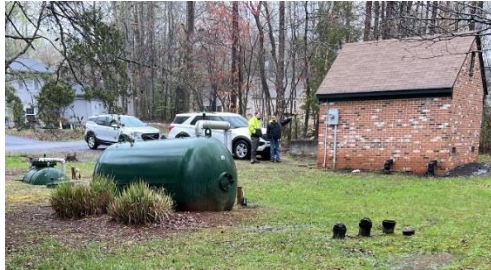
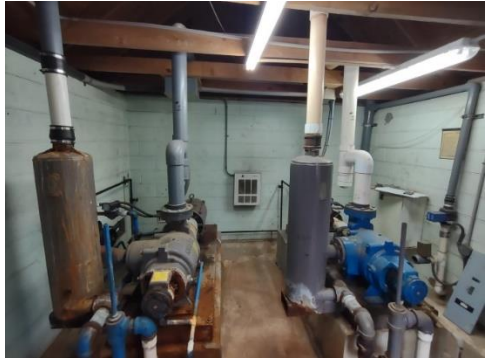
Vacuum Station ID	Condition Assessment Key Observations
	<ul style="list-style-type: none"> <li>• Electrical systems are beyond end of useful life and code required clearances are not provided.</li> <li>• A portable generator plug is provided to power the station during power outages.</li> </ul>
<p data-bbox="370 369 475 396"><b>Station I</b></p>

<ul style="list-style-type: none"> <li>• The building consists of CMU and slab on grade construction with brick veneer. Building is generally in acceptable condition for continued use.</li> <li>• Building footprint is slightly smaller than desired to house SC3 vacuum pumps and controls, but could be used with reduced clearances or by locating some electrical equipment in outdoor enclosures.</li> <li>• Vacuum system operates with one pump on and one pump in standby. One pump is more than 20-years old, exhibits heavy corrosion, and is beyond useful life. The other pump appears to be a newer model but is missing nameplate. The newer pump is in moderate condition (slight rattle and whine).</li> <li>• Sewage pump station equipment is beyond end of useful. Piping and steel frame heavily corroded. Pumps rebuilt in 2011.</li> <li>• Concrete wetwell concrete is exhibits corrosion, concrete spalling, and root intrusion.</li> <li>• Odor control unit is a stand-alone biofilter in CMU block basin. Structure appears to be near end of useful life.</li> <li>• Electrical systems are beyond end of useful life.</li> <li>• A portable generator plug is provided to power the station during power outages.</li> </ul>

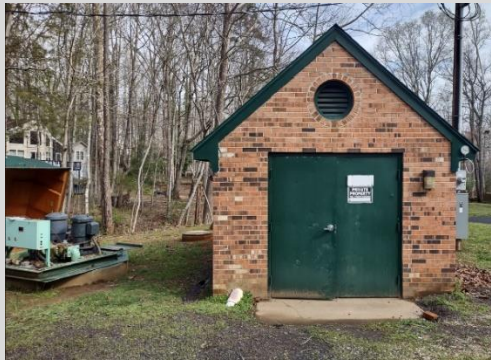
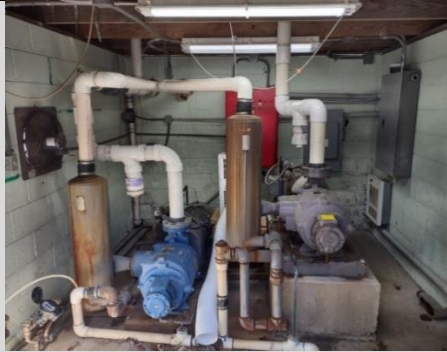
<p data-bbox="370 1142 475 1169"><b>Station J</b></p>

<ul style="list-style-type: none"> <li>• The building consists of CMU and slab on grade construction with brick veneer. CMU exhibits minor step cracking. Building is generally in acceptable condition for continued use.</li> <li>• Building footprint is inadequate to house existing SC5 vacuum pumps and proposed SC7 vacuum pumps and controls with appropriate clearances.</li> <li>• Odor control unit is attached to the building. The RSA has noted deterioration of exterior walls over time in this configuration.</li> <li>• Vacuum system requires both pumps to run continuously, no redundancy. One vacuum pumps was installed in 2011, and one is in excess of 20 years old. Pumps are nearing/beyond end of useful life.</li> <li>• Sewage pump station is approximately 30-years old &amp; is beyond useful life. Pump motors were rebuilt in 2011.</li> <li>• Concrete wetwell exhibits concrete degradation with exposed aggregate.</li> <li>• Electrical systems (except generator) are beyond useful life and require replacement.</li> </ul>

<ul style="list-style-type: none"> <li>A 200A transfer switch is provided to allow a portable generator to power the station is provided.</li> </ul>
<p><b>Station K/L</b></p>

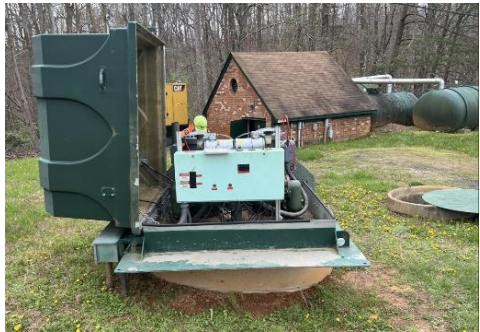
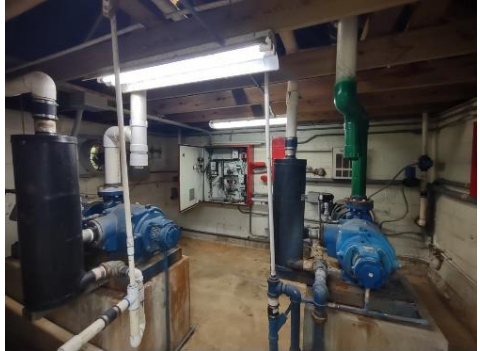
<ul style="list-style-type: none"> <li>The building consists of a partially buried CMU and slab structure with brick veneer. Minor step cracking is evident in CMU and exterior reinforcement is installed to stabilize the structure. Moderate cracking of the base slab is visible. Water damage/mold to the roof sheathing and rafters is present, but the leaking roof appears to have been repaired.</li> <li>Access to the building is down a flight of concrete stairs. The floor slab is below grade and the building drain is shared with the stairwell drain, which was clogged during the site visit.</li> <li>Building footprint is inadequate to house proposed SC7 vacuum pumps and controls with appropriate clearances.</li> <li>Vacuum system requires both pumps to run continuously, no redundancy. One vacuum pumps was installed in 2018 and is generally in fair condition other than minor corrosion to the housing. The other vac pump is in excess of 20 years old and is beyond end of useful life.</li> <li>The vacuum system is configured differently from other stations. Each vacuum pump serves dedicated receiving/equalization tanks and portion of the collection system. The vacuum pumps do not back each other up. Overflow tanks are not provided.</li> <li>One of the receiving tanks exhibited a leaking corroded/failed weld.</li> <li>Sewage pump station base plate, piping, valves, and lower pump unit (volute) were replaced in 2016. Original pump motors/upper pump unit were retained and were rebuilt in 2011. Pump control panel is also original construction (1990s).</li> <li>Wet well epoxy liner is in adequate condition.</li> <li>Odor control unit was recently (&lt;10 years) replaced with stand-alone biofilter in fiberglass basin.</li> <li>Electrical systems (except generator) are beyond useful life and require replacement.</li> <li>A 125 kW backup generator was installed in 2013.</li> </ul>

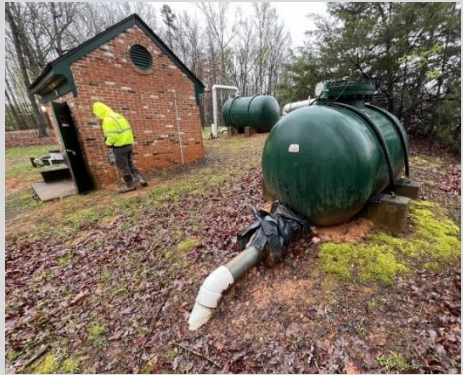
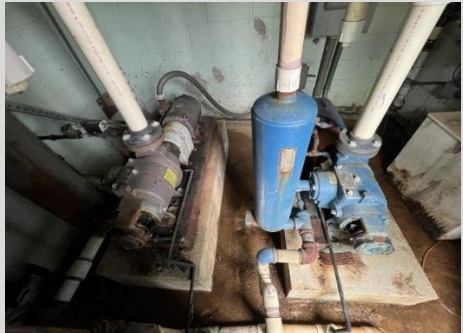
<ul style="list-style-type: none"> <li>• The building consists of slab on grade with CMU block walls.</li> <li>• One of the double doors is corroded and does not open.</li> <li>• The roof consists of light wood trusses and asphalt shingles</li> <li>• Building footprint is too small to provide required clearances for existing and proposed equipment and electrical panels.</li> <li>• Vacuum system is equipped with duplex SC2 pumps. Both vacuum pumps are at least 20 years old and are beyond end of useful life.</li> <li>• The vacuum system check valves are installed above grade. Fiberglass insulation is wrapped around the valves to protect from freezing.</li> <li>• A new odor control unit is provided (less than 5 years old).</li> <li>• The station is not equipped with an overflow tank. RSA staff noted that the single receiving tank is inadequately sized for the current flows.</li> <li>• Electrical systems are beyond end of useful life and code required clearances are not provided.</li> <li>• A portable generator plug is provided to power the station during power outages.</li> </ul>

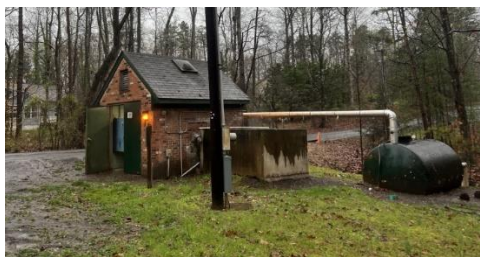
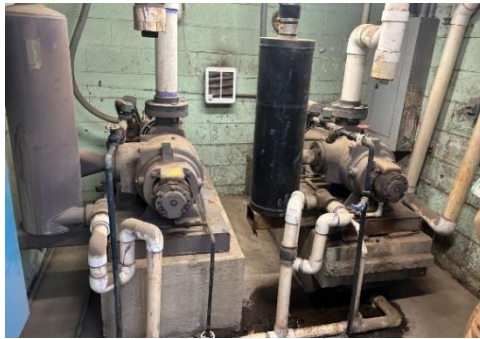
<p><b>Station N</b></p>

<ul style="list-style-type: none"> <li>• The building consists of CMU and slab on grade construction with brick veneer. Building is generally in acceptable condition for continued use.</li> <li>• Building footprint does not provide adequate clearances around equipment for proper maintenance. Any additional electrical/controls panels would need to be located in outdoor enclosures.</li> <li>• Odor control unit is attached to the building. The RSA has noted deterioration of exterior walls over time in this configuration.</li> <li>• Vacuum system operates with one pump on and one pump in standby. Both pumps are more than 20-years old and are beyond the end of useful life.</li> <li>• The pipe connecting the equalization tank to the wet well was leaking, and the check valve vault was full of scum.</li> <li>• Sewage pump station equipment was replaced in 2022.</li> <li>• Concrete wetwell concrete was rehabilitated and coated with epoxy liner in 2022.</li> <li>• Electrical systems are beyond end of useful life.</li> <li>• A portable generator plug is provided to power the station during power outages.</li> </ul>
