DIXON

Subject: Condition Assessment Inspection Services for the 100,000 Gallon Cone Roof

Dixon Engineering performed an inspection on April 4, 2024 on the 100,000 gallon cone roof water tower located in the City of Waterloo, Wisconsin. The purpose of the inspection was to perform a condition assessment of the entire structure to determine the feasibility of maintaining the structure as a landmark/antenna support structure. The inspection was performed by James Rowley, Structural Engineer, and Joseph T. Hoban, PE.

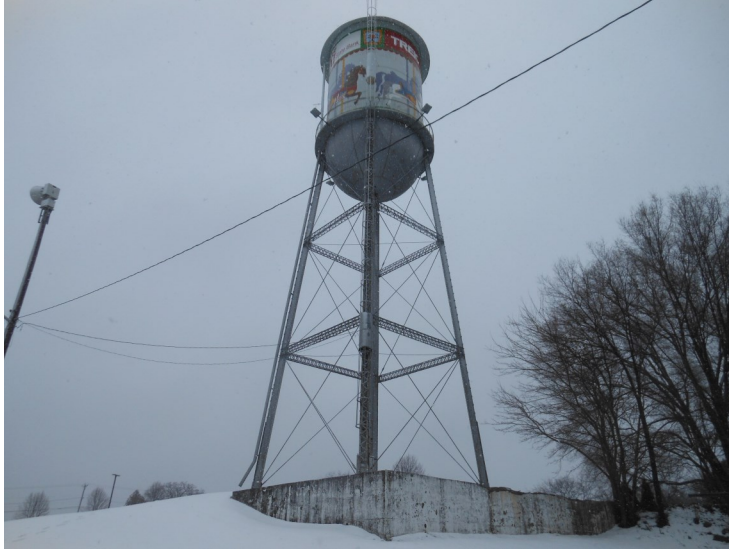
1) 100,000 gallon cone roof elevated water tank located in Waterloo, Wisconsin.

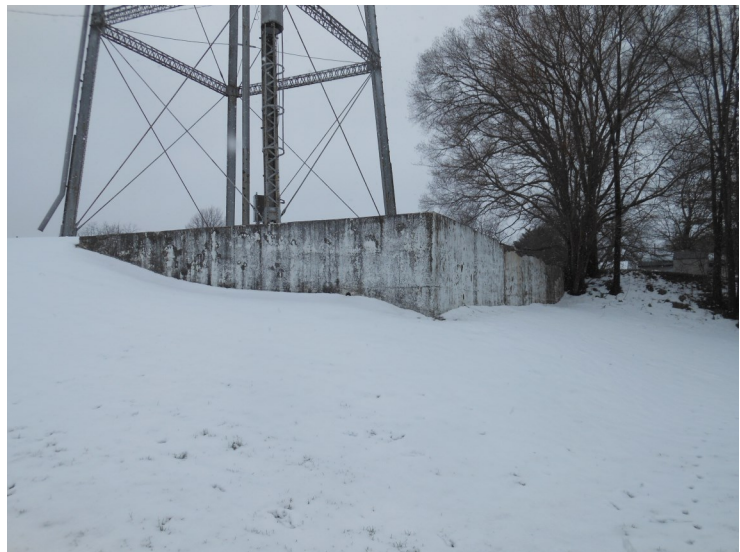
2) The tank base is surrounded by a concrete retaining wall.

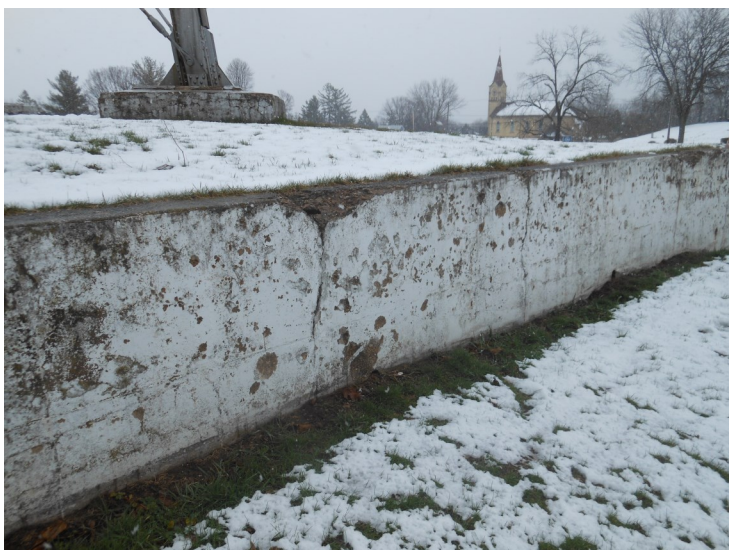
The tank is located in an unfenced area near a church parking lot. There is an electrical line that routes from an adjacent pole to one of the legs. There is a concrete retaining wall around the perimeter of the tank base. The concrete retaining wall is in fair condition overall with numerous spalls. The retaining wall appears plumb and generally structurally sound. The site is generally well-kept with no vegetation encroachment on the tank.

3) The concrete retaining wall is in fair condition with numerous spalls.

1. Repair spalls on the concrete foundations and retaining walls. The estimated cost is \$20,000.
2. Weld plates over the holes in the roof. The estimated cost is \$5,000.
3. Abrasive blast clean the exterior inside a dust tight containment system and repaint with a urethane system. The estimated cost is \$180,000 plus \$100,000 for containment.
4. Install a fall prevention device on the leg/sidewall ladder. The estimated cost is \$6,000.
5. Long term budget recoating the exterior every 15 years (after the initial abrasive blast cleaning and repaint).

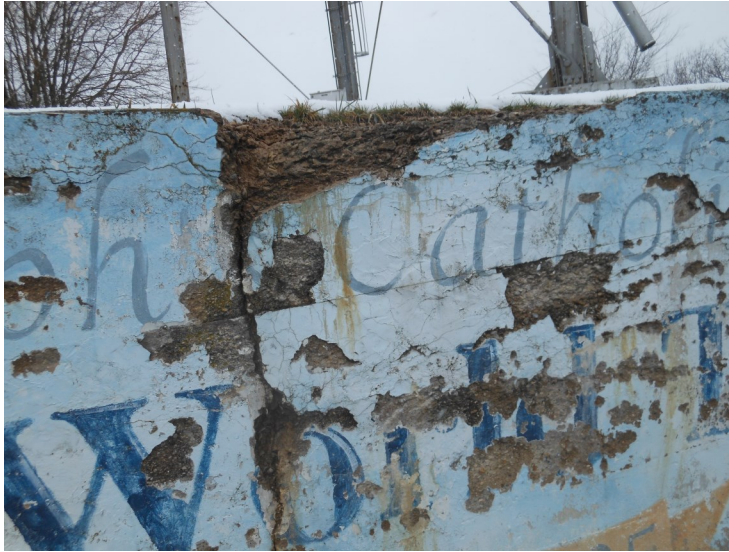
4) Same.

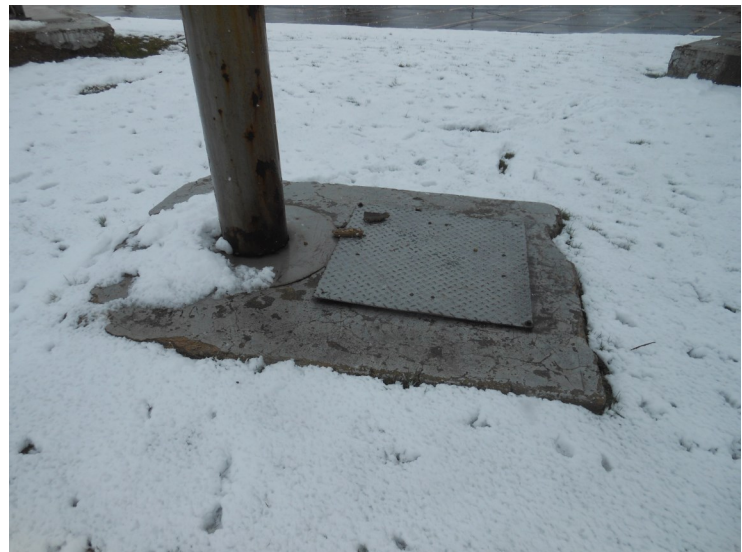
Foundation exposed: Yes
Exposed height: 2-6 inches
Exposed foundation condition: Fair
Damage or deterioration: Yes
Type of damage: Spalls/chips and exposed aggregate
Severity: Moderate
Total spall area: 3 square feet
Foundation coated: Yes
Coating condition: Fair
Describe coating: Delamination and erosion
Undermining of foundation: No

5) The riser foundation is in fair condition overall. There is a pit with a steel plate cover.

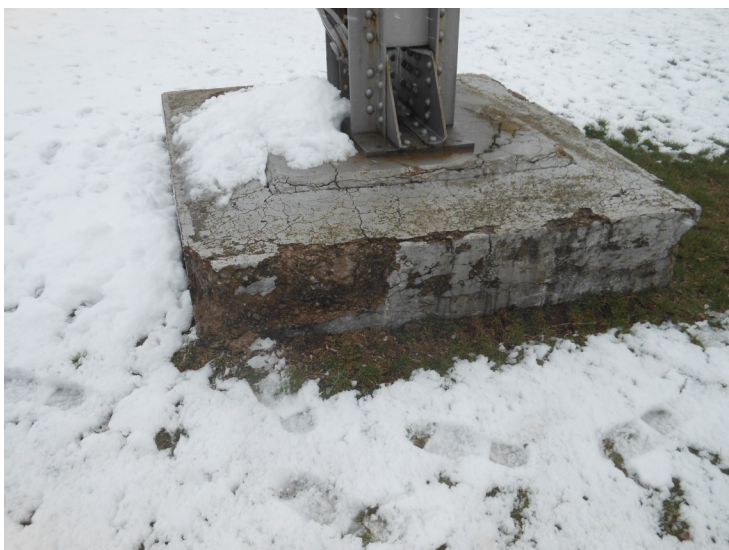
The exposed concrete foundations are in poor to fair condition overall. It appears that some concrete was added to the original concrete foundations. There are numerous spalls throughout the concrete foundations. There is a survey benchmark located on the leg foundation with the ladder.

Leg foundation comments: **Additional concrete was added around the original foundations. Spalls are approximately 3 inches deep at maximum**

6) Typical concrete leg foundation is in poor condition overall.

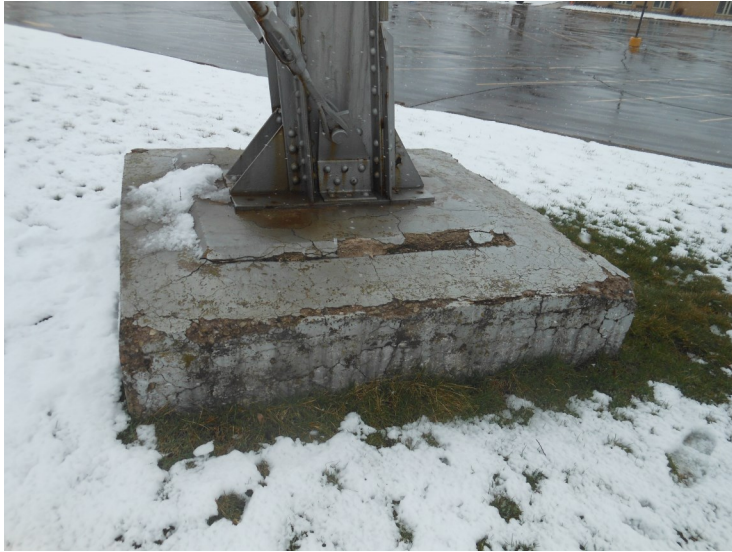
7) Same.

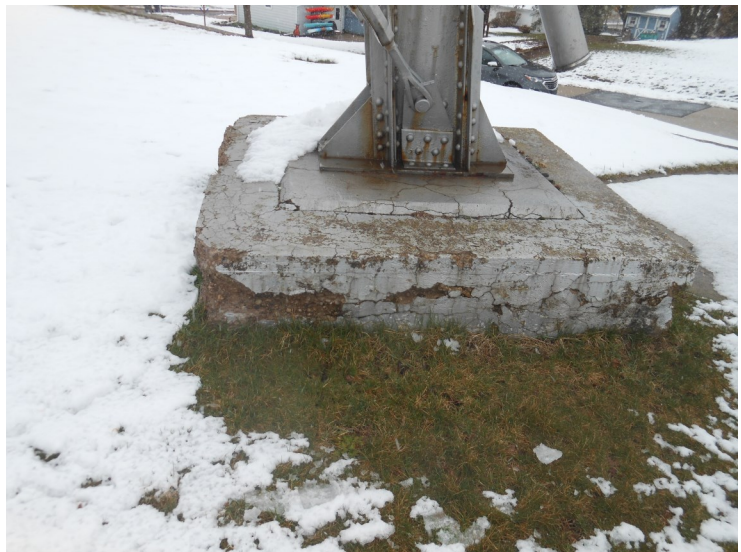
8) Same.

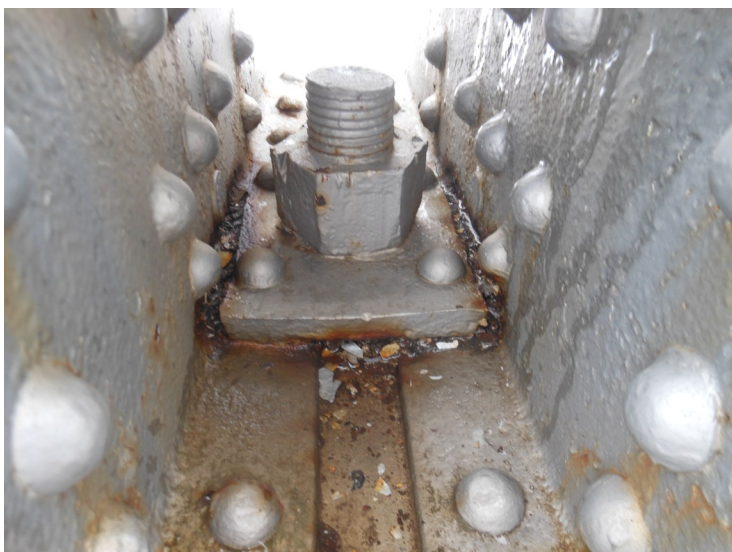
There are no anchor bolts at the wet riser. There is one 2 inch diameter anchor bolt at each of the four legs. The anchor bolts are in good condition overall with no significant deterioration.

9) Typical leg anchor bolt is in good condition.

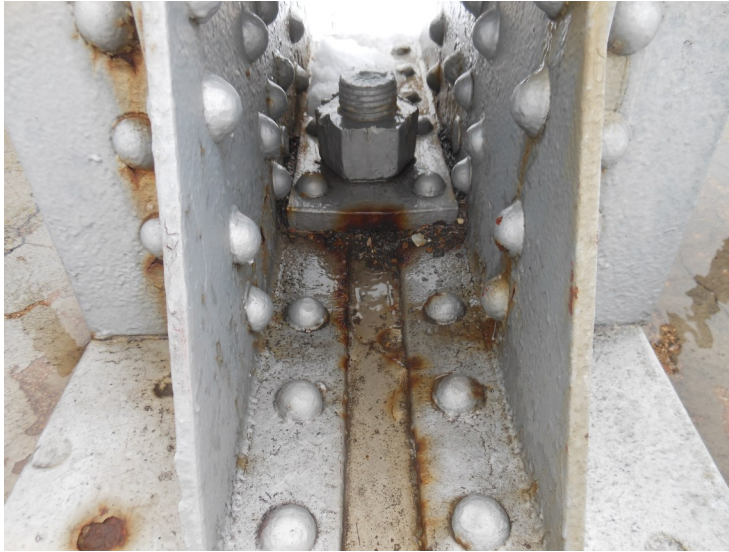
10) Same.

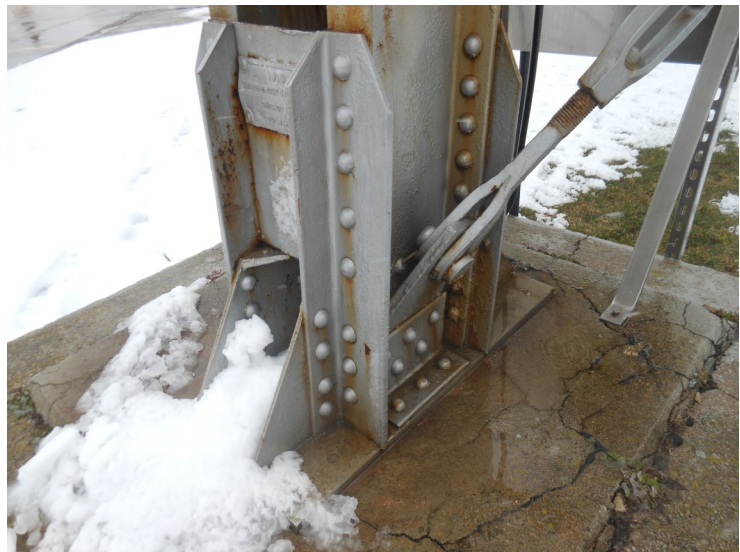
11) Typical leg base is in good condition.

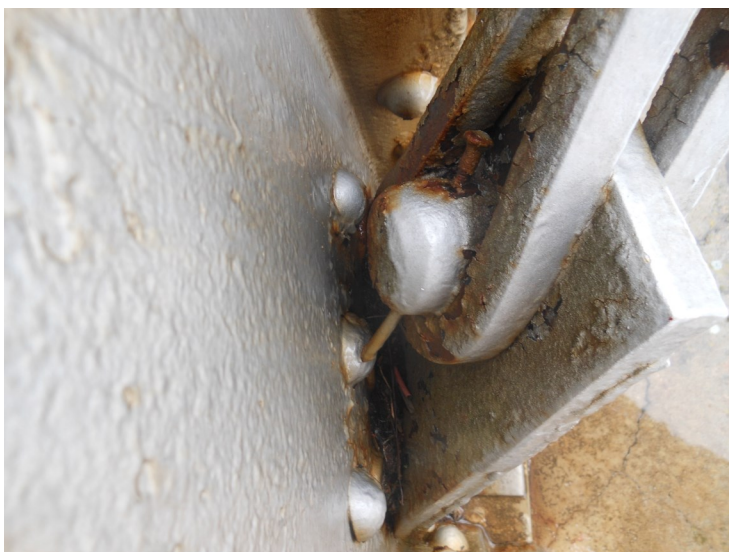
12) Typical sway rod connection is in good condition.

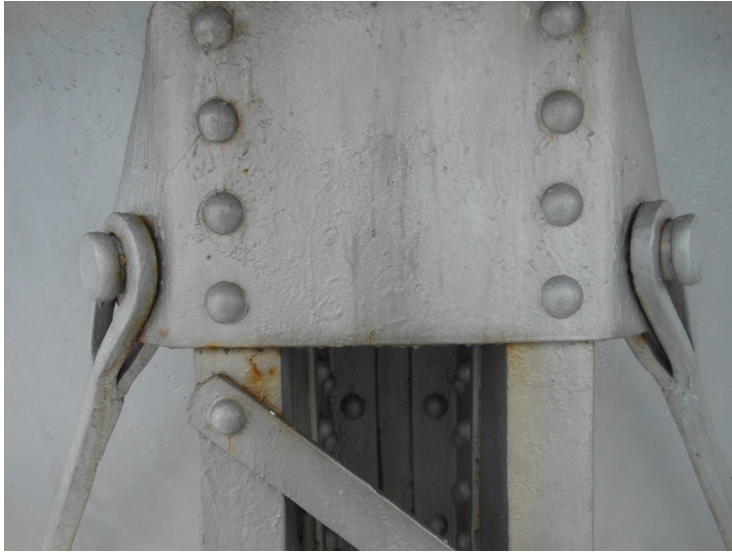
13) Same.

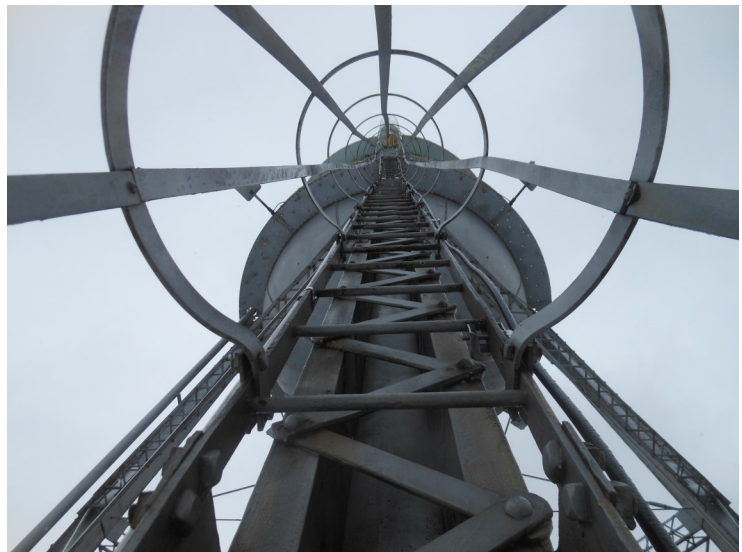
The exterior leg ladder starts 4 feet above the leg foundation and extends up to the balcony. The leg ladder is equipped with a cage and a vandal guard that are in good condition. The ladder is not equipped with a fall prevention device. The ladder is in good condition overall but does not meet OSHA size requirements. The toe clearance and length of rungs are undersized. The leg ladder cage has an opening at the balcony for access and continues to the roof. There are rungs welded to the roof to access the finial ball at the peak.

14) The leg ladder is in good condition. The ladder is not equipped with a fall prevention device.

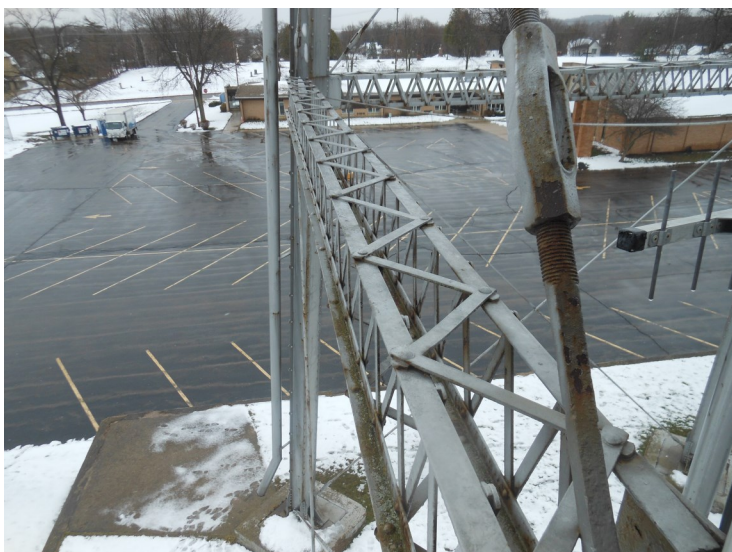
15) Typical strut is in good condition.

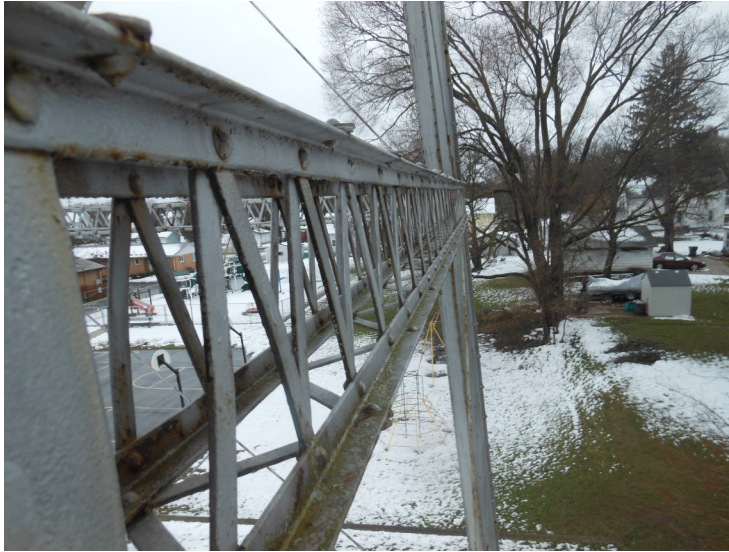
16) Same.

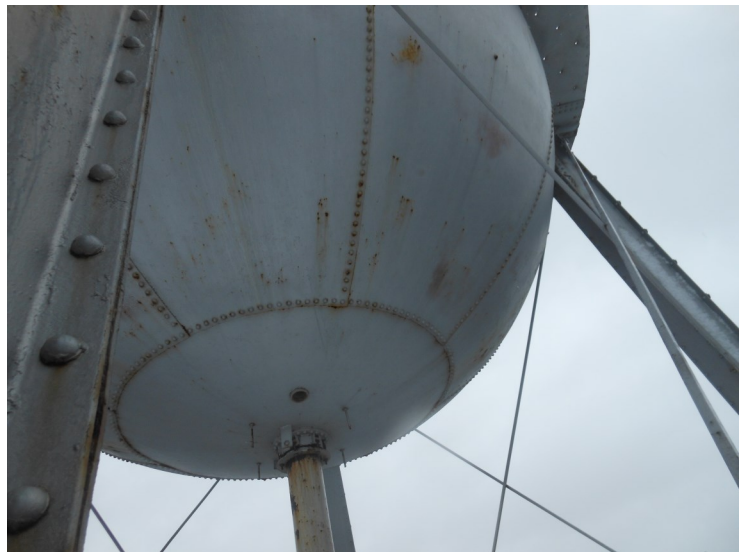
17) The bowl is in good condition overall. The coating is in fair condition.

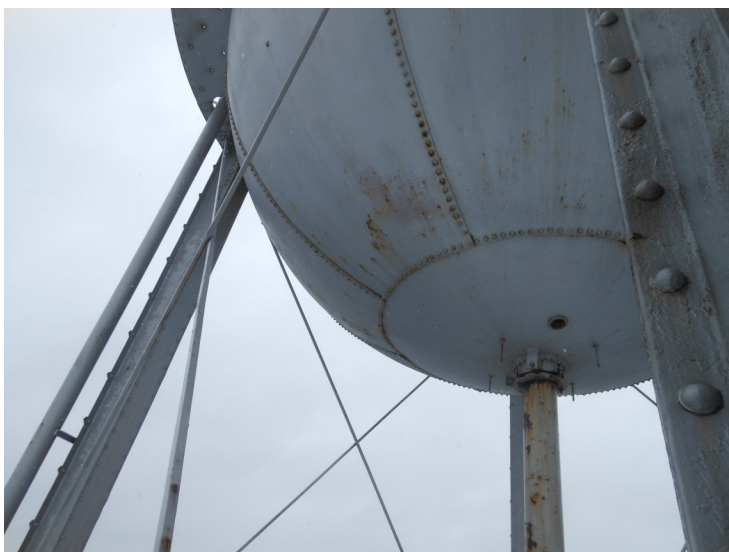
18) Same.

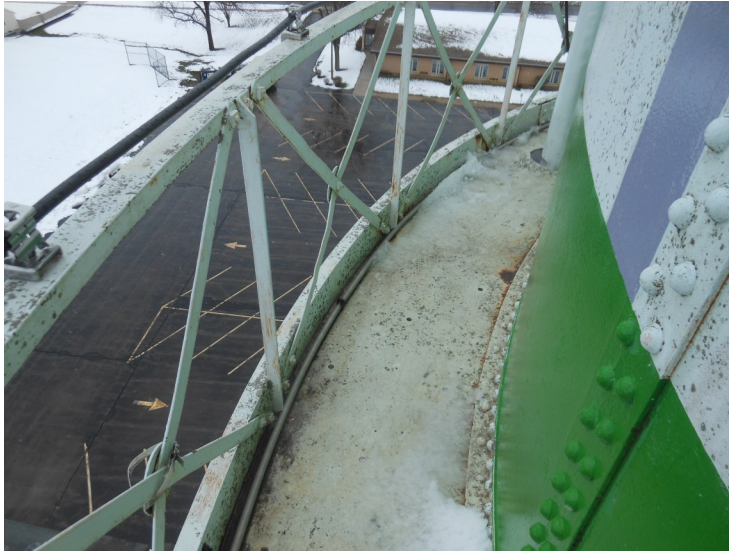
The exterior balcony is in good condition overall. The balcony and railing do not conform the current OSHA requirements. The railing height is undersized and there is no midrail. The tank does not have a roof handrail.

19) The balcony is in good condition overall.

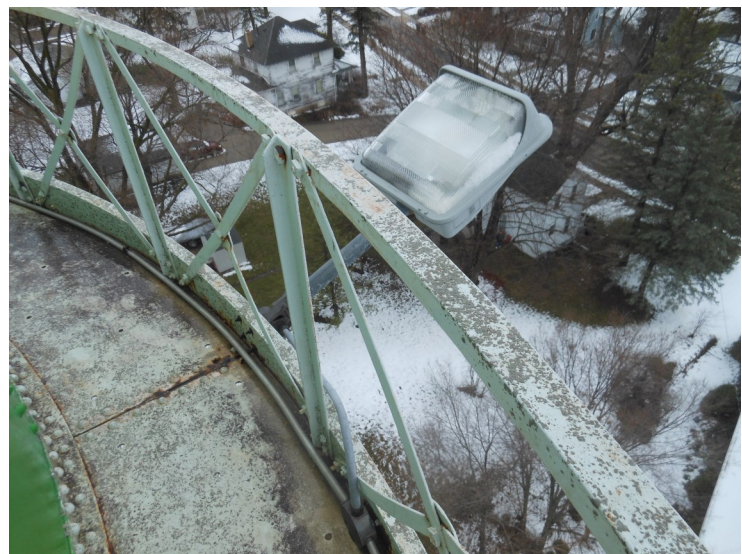
20) Same.

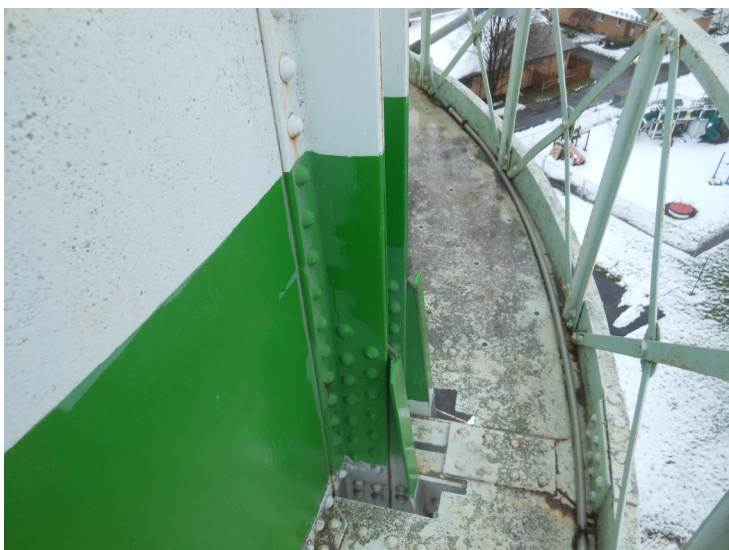
21) Typical leg connection to the sidewall is in good condition.

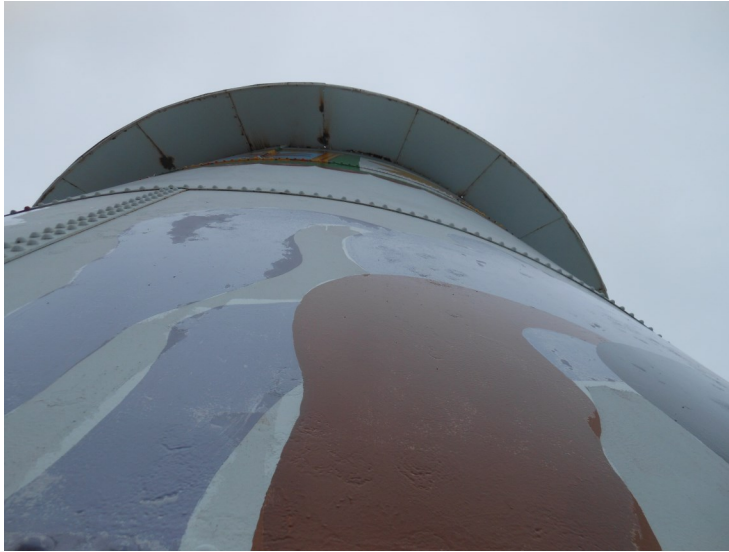
22) The sidewall is in good condition. The coating is in good condition.

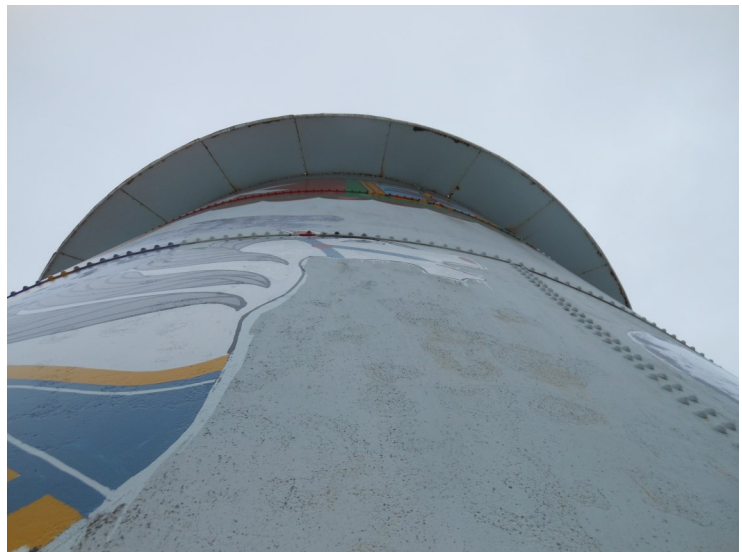
23) Same.

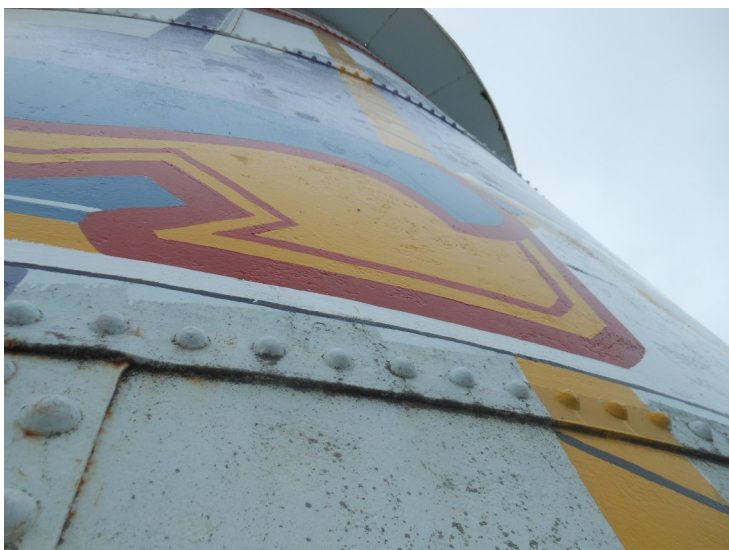
24) The riveted seams on the sidewall are in good condition.

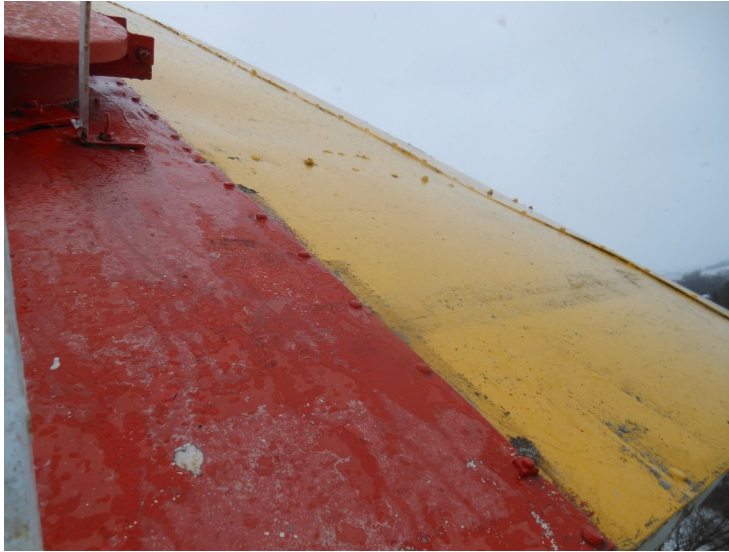
25) The roof is in good condition overall. The coating is in good condition.

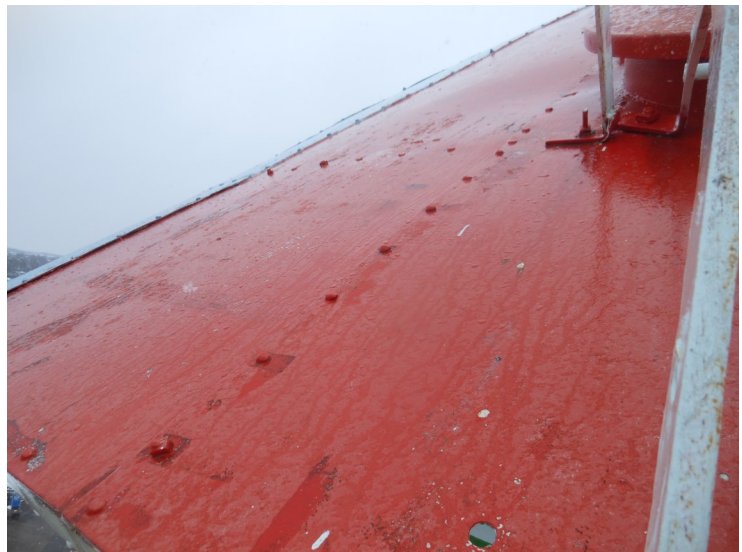
26) Same.

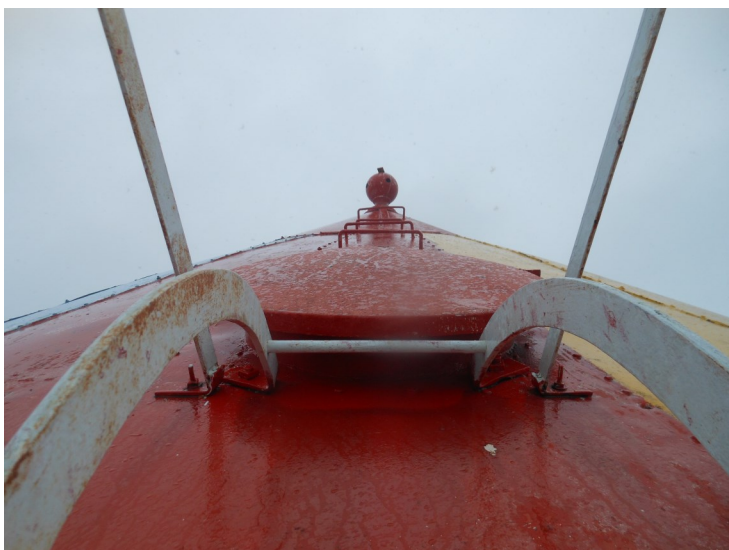
27) There are rungs on the roof leading up to the finial ball at the peak.

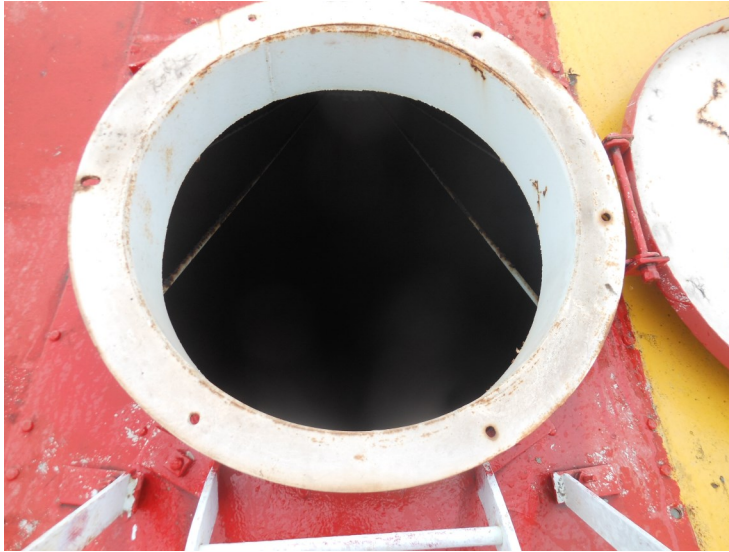
28) The wet interior roof hatch is in good condition.

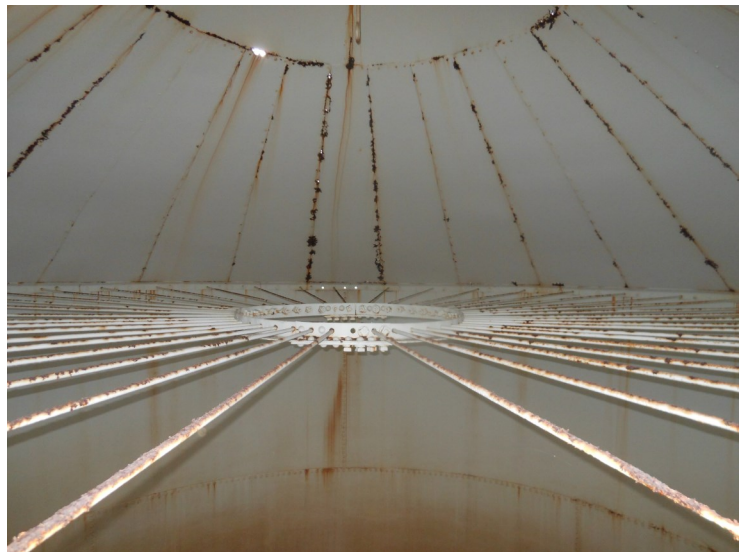
There are several holes in the roof plates throughout. The holes can let water into the interior of the structure and accelerate corrosion.

29) The wet interior roof is in good condition overall. There are small holes throughout.

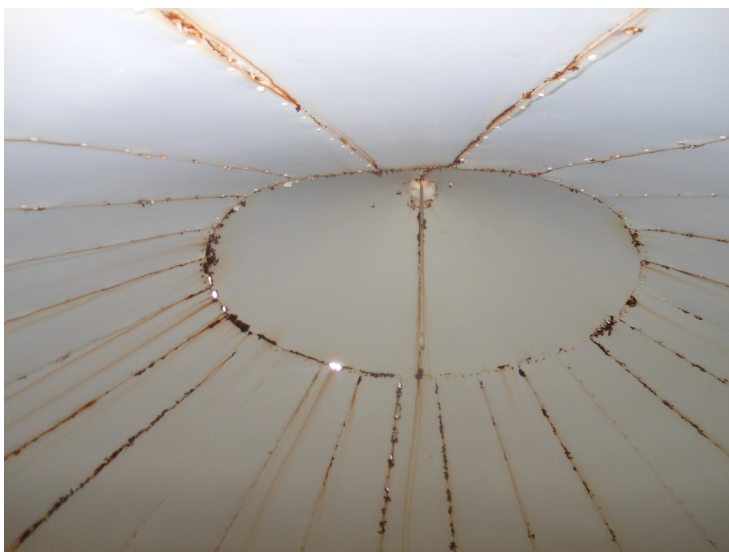
30) Same.

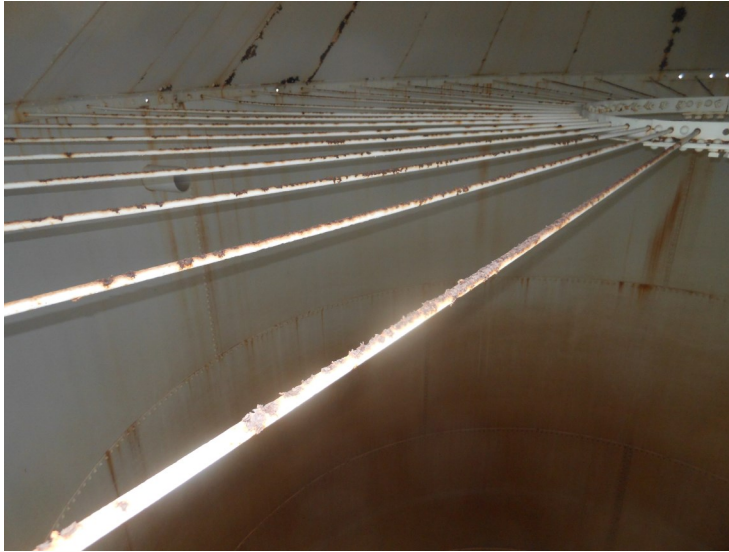
31) The wet interior spider rods are in good condition.

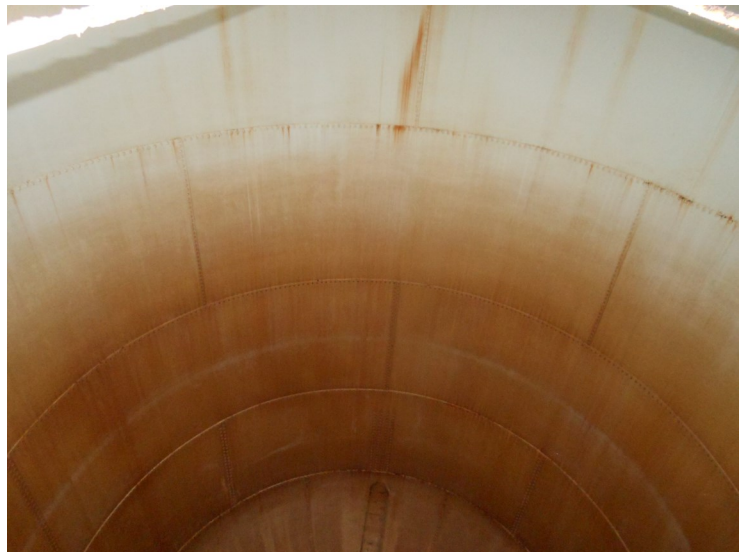
32) The wet interior sidewall is in good condition. The coating is in fair condition.

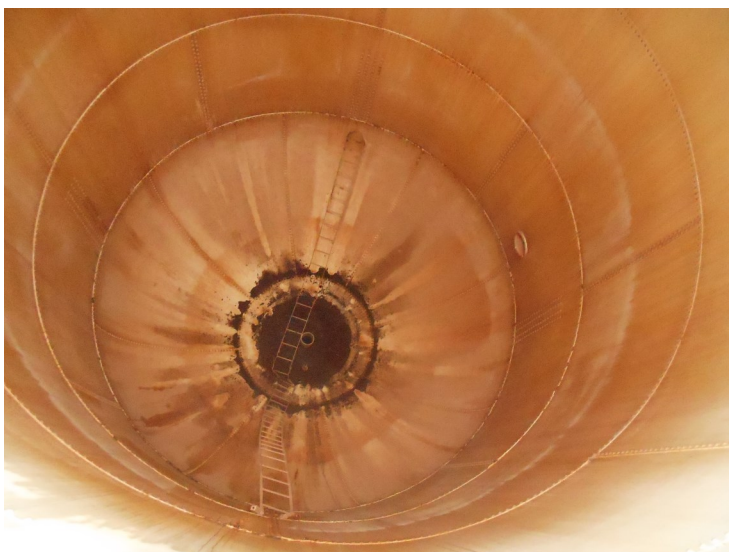
33) The wet interior bowl is in good condition. The wet interior ladder is laying in the bowl.
